Application of the Photoelastic Coating Technique in Car Suspension Failure Analysis

Keywords: Trailing Arm Failure, Photoelastic Coating Technique, Fatigue Fracture

Abstract. The article presents the results of an experiment carried out to determine the cause of damage to the right rear trailing arm of a passenger car. The routine inspection of the vehicle and the test of the arm damaged during the running have indicated production defects as the cause of a dangerous failure. The results of the expertise were questioned and the thesis was formulated that the process of the rocker failure was initiated during the theft of wheels by raising the car in a manner inconsistent with the manufacturer's instructions. A simulation of this event was carried out by lifting the vehicle on the trailing arm. To assess the effort of the rocker, the photoelastic coating technique was used. The analysis of the measurement results showed that the theft incident could not initiate the fatigue process that led to the failure of the trailing arm.

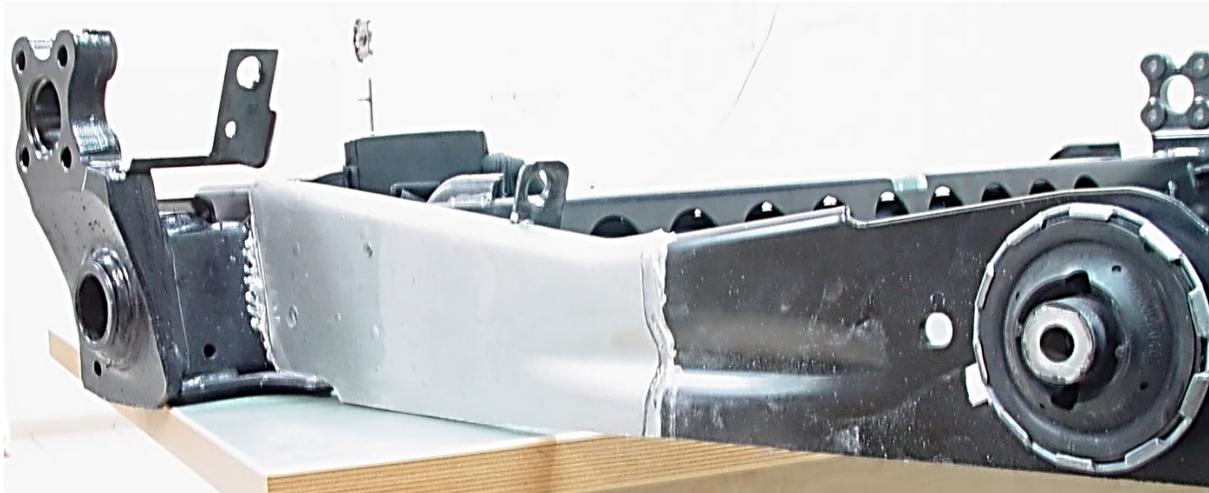
*Fig. 1. View of the photoelastic coating on the trailing arm's side surface
The rear beam prepared in this way was mounted in the same, technically efficient car model.*

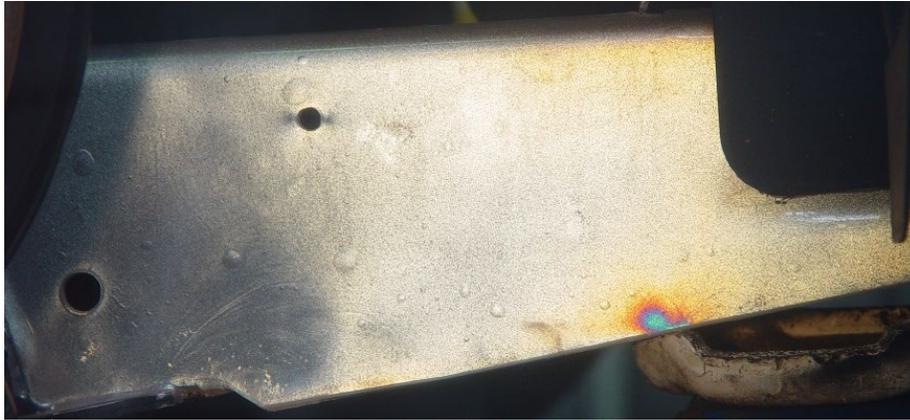
Fig. 2. Full-order isochromatic fringes – lifting phase A ($N_{max} \cong 1.1$)

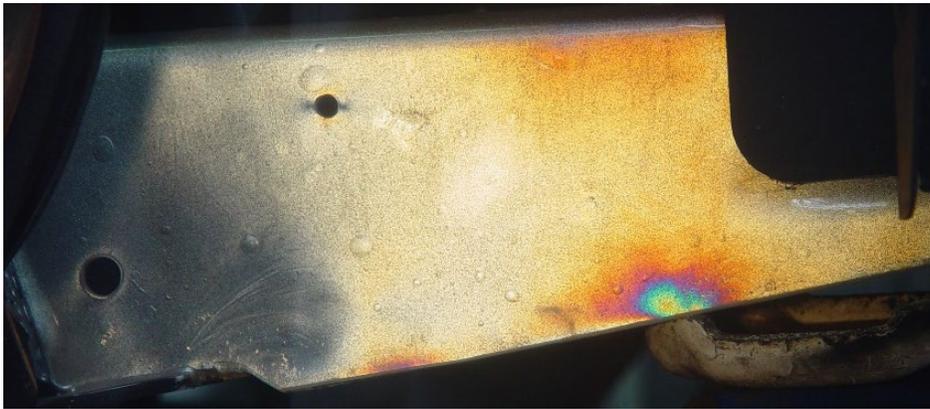
Fig. 3. Full-order isochromatic fringes – lifting phase B ($N_{max} \cong 1.5$)

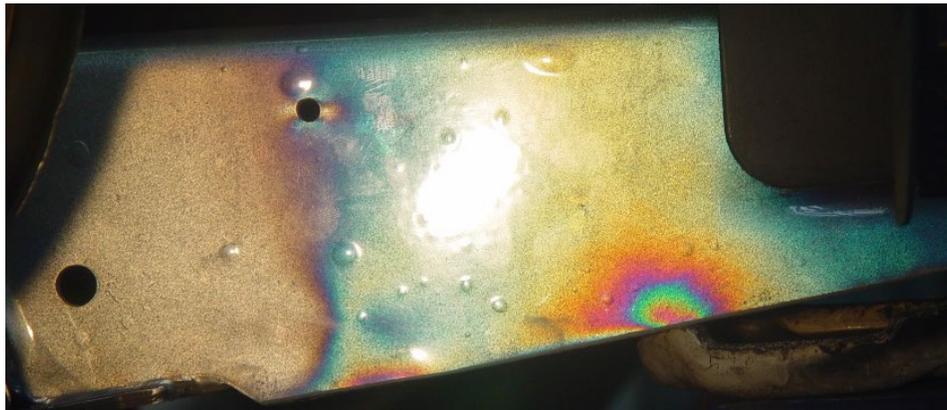
Fig. 4. Half-order isochromatic fringes – lifting phase C ($N_{max} = 2.35$)

During the lifting, an increase in the stress value was initially observed (max approx. 410 N/mm² in phase C), followed by its decrease due to the inclination of the body and the shift of the vehicle center of gravity to the left (phase D). After removal of the jack and support on bricks, a low isochromatic fringe order ($N \approx 0.3$) was observed at the location of the jack head impact (area marked with a circle in Fig. 6), so the yield point was exceeded in this region; however, the stress corresponding to the plastic strain reached only approx. 50 N/mm².

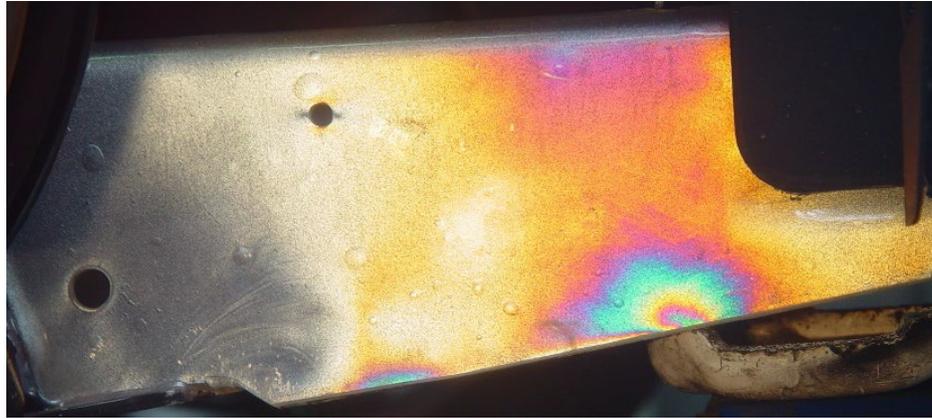
Fig. 5. Full-order isochromatic fringes – lifting phase D ($N_{max} \cong 2.0$)

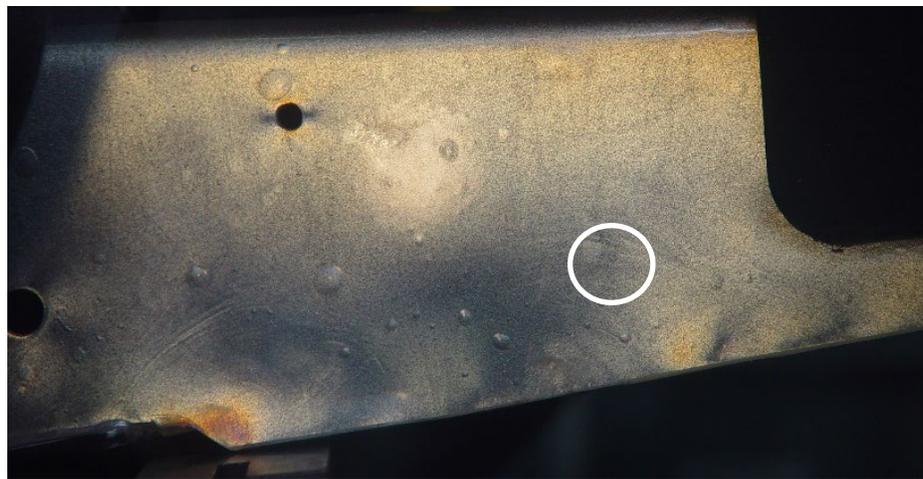
Fig. 6. Full-order isochromatic fringes – phase E (supporting on the bricks) ($N_{circle} \cong 0.3$)

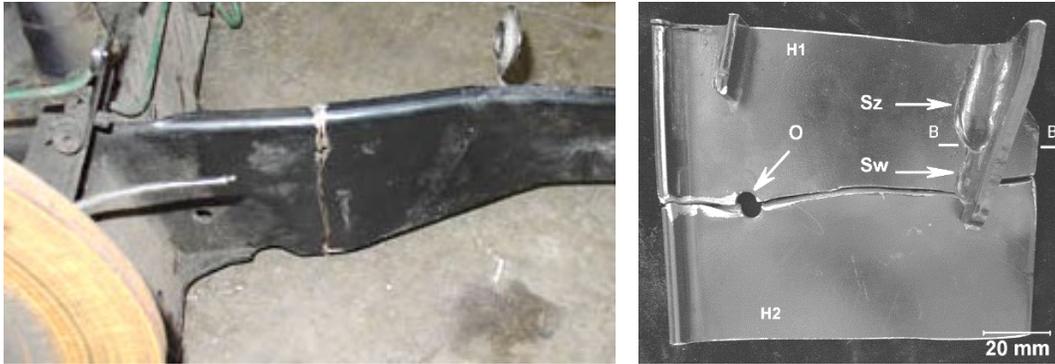
When analyzing registered isochromatic images, the location of maximum isochromatic fringe order N was compared with the fracture line in the rocker damaged during the accident - Fig. 7a. This fracture runs through the hole for fixing the handbrake cable, approximately perpendicularly to the upper edge of the rocker, and it is located in the area covered by the wheel(!). Fig. 7b shows its course from the inside in a sample cut for the metallographic research. As it can be seen, the fracture also runs through the end of the weld fixing the reinforcement (rib) to the rocker.

In contrast, during the wheel theft simulation, the maximum values of the isochromatic fringes occurred in the place of impact of the jack head on the lower edge of the trailing arm, away from the fracture.

Fig. 7. View of the fracture line: a) from the outer side of the arm, b) from the inside (view rotated 90 ° to the left, Sz - main weld, Sw - preliminary weld, H1, H2 - designation of sample fragments)

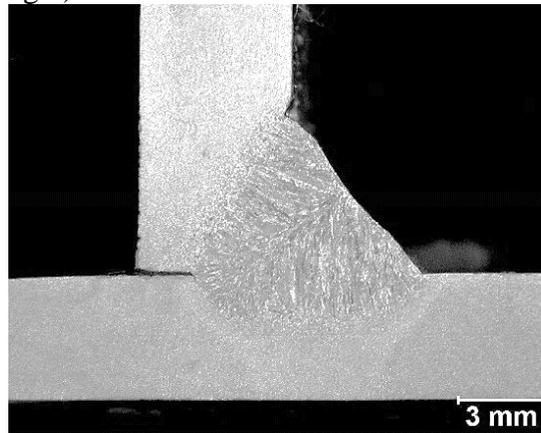
- the ending of the connecting joint (8 mm) and the main joint (20 mm) before the end of the reinforcing rib, visible in Fig. 6b,
- no weld penetration (Fig. 7),
- gas bubble in the weld and non-metallic inclusions originating from the paint layer (not removed before welding - Fig.8).

Fig. 7. No penetration in the joint connecting the rib to the trailing arm

Each of these defects causes stress concentration, which in combination with a variable load resulted in the formation of fatigue-type fracture with a ductile fracture zone.

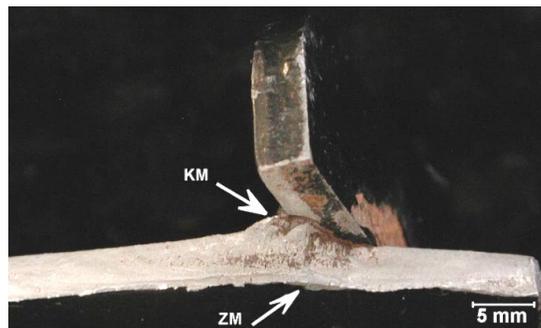
Fig. 8. The view of the fracture in the rib's area - the lack of penetration and not removed varnish layer (KM - fragile fracture zone, ZM - fatigue zone)
