Impact of Decarburization on the Hardness of the Rails Running Surface

MIKŁASZEWICZ Ireneusz^{1,a}

¹ Instytut Kolejnictwa (The Railway Research Institute), Materials & Structure Laboratory, 50, Chłopicki Street, 04-275 Warsaw, Poland

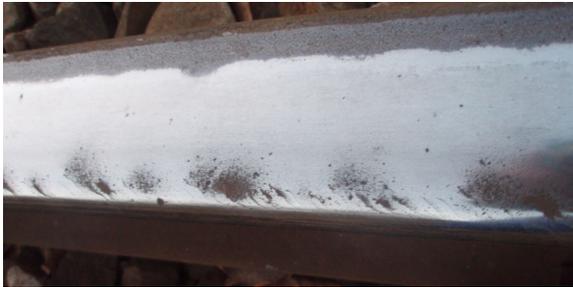
extends, subjected to strong strengthening of the rail head surface. During this period, the surface layer wears out as a result of wheel-rail interaction, while creating defects in the form of rolling edge cracks occurring mainly in track curves with small radii and straight sections in places with unstable track surface. This kind of defect occurs frequently during operation, to a varying degree connected with decarburization, which can be classified as a fatigue-type defect. Minor cracks in the rail head edges arise in the track curves as a result of wheel flange action, which develop in further operation. These cracks are formed as a result of strong deformation of the softer surface layer of the rail head (Fig.1).

Fig. 1. Rail edge defect

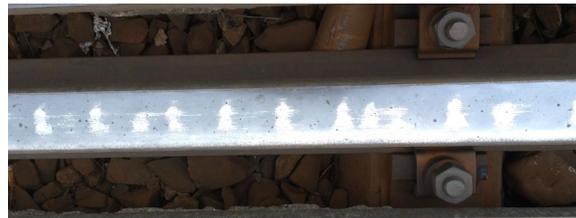
At this stage, there also appears a phenomenon of wave formation and wear of the rail surface, partly linked to decarburization (Fig. 2). This particularly applies to the formation of short waves with low amplitude which probably originate from the uncushioned masses of rolling stock in reaction with the decarburized surface of the rail [8].

Fig. 2. Defect in rail waviness

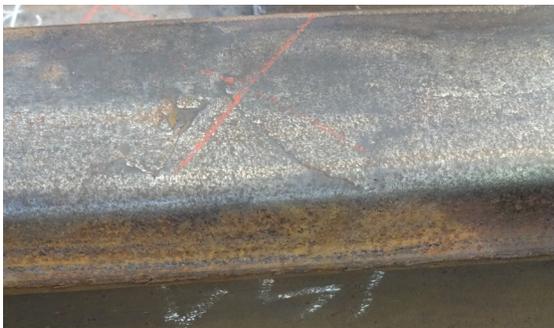
Then defects of squat (Fig. 3) and shelling (Fig. 4) types can be distinguished. They are also connected with the surface decarburization, usually arising as a result of the local delamination of the surface layer of the rails and its chipping, as the rails previously underwent so-called spinning or sudden braking of the wheels of the power unit. Also the sticking and flaking of the running surface is related to the micro-slip and friction energy in the wheel-rail interaction and the quality of the rail surface structure.

Fig. 3. Squat rail defect

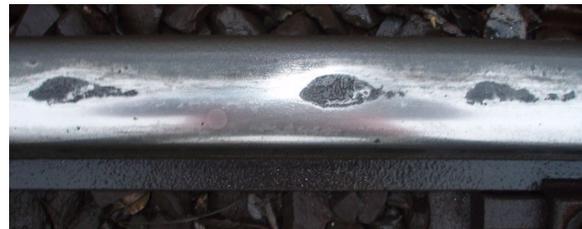
Fig 4. Shelling rail defect

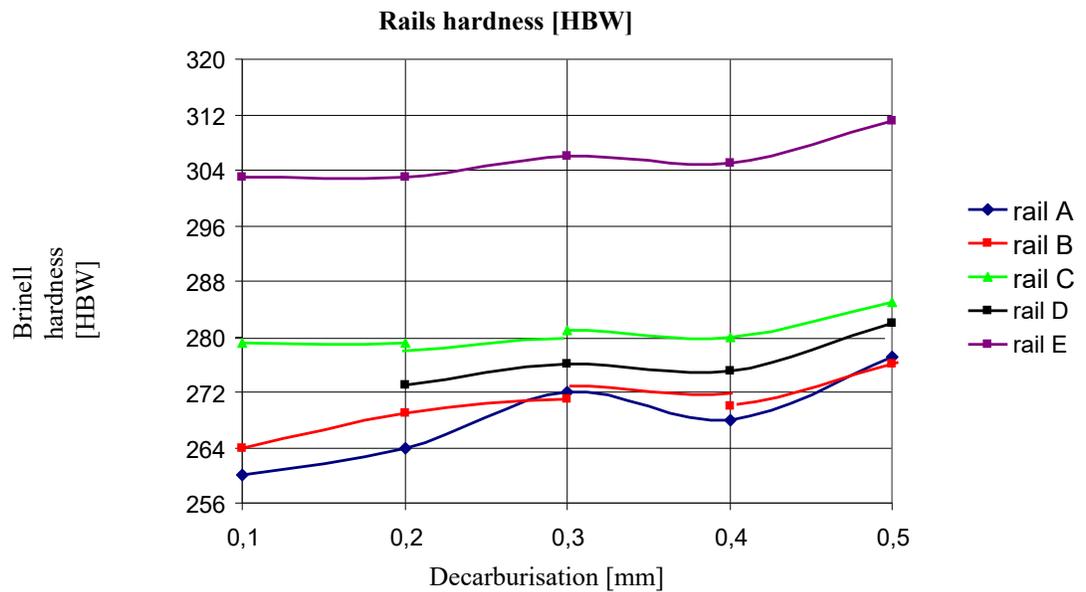
Figures 6 and 7 present the results of measuring the Vickers HV5 and Brinell HBW hardness depending on the thickness of the ground layer from which surface decarburized was removed. The graph (Fig. 6) shows that the tested rail samples showed hardness in the range of 260 to 310 HBW depending on the thickness of the ground layer. Therefore, the minimum thickness of the layer removed from the rail running surface, guaranteeing the achievement of the required hardness of minimum 260 HBW, should be 0.30 mm.

Fig. 6. HBW hardness distribution of tested rails

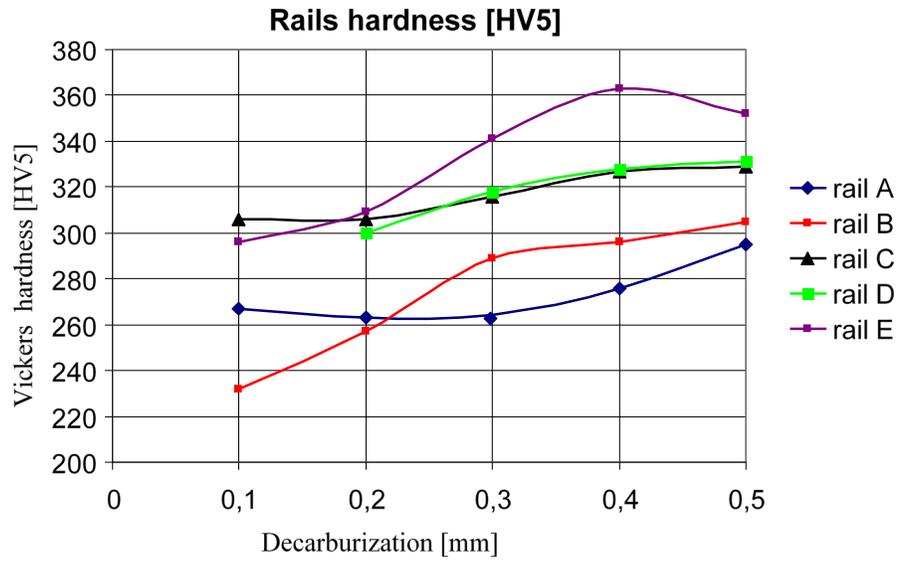
HV5 measurements, i.e. 260 to 363 HV5 hardness units, show a greater difference in hardness of the tested samples (Fig. 7). Also in this case, the minimum thickness of the ground layer that guarantees the required hardness of the rail running surface should be 0.30 mm.

Fig. 7. HV5 hardness distribution of tested rails

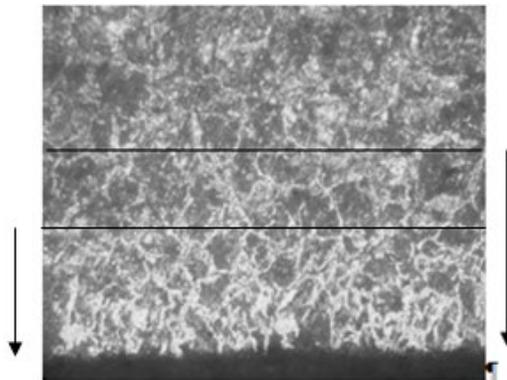
Figure 8 shows the microstructure of the decarburized surface of the manufacturer's rail sample marked with the letter A. The line indicates the permissible decarburization for the rail of 0.50 mm, and the minimum 0.30 mm securing the required hardness, and Fig. 9 shows the microstructure of the sample decarburized layer 0.30 mm of the rail marked with the letter E. Bainitic-martensitic microstructure was not found in the tested samples.

Fig. 8. Sample of rail no. A with 0.50 mm decarburization, area 100x

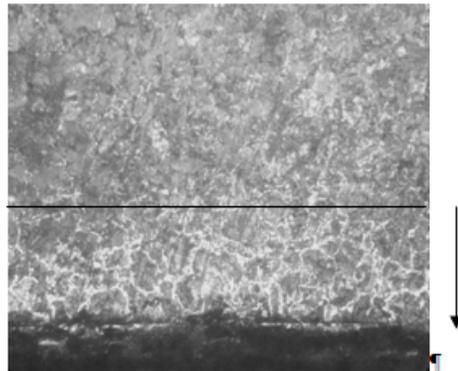
Fig. 9. Sample of rail no. E with 0.30 mm decarburization, area 100x
