Investigations of the Head Check Defects in Rails

¹Institut Kolejnictwa (The Railway Research Institute), Materials & Structure Laboratory, 50, Chłopicki Street, 04-275 Warsaw, Poland

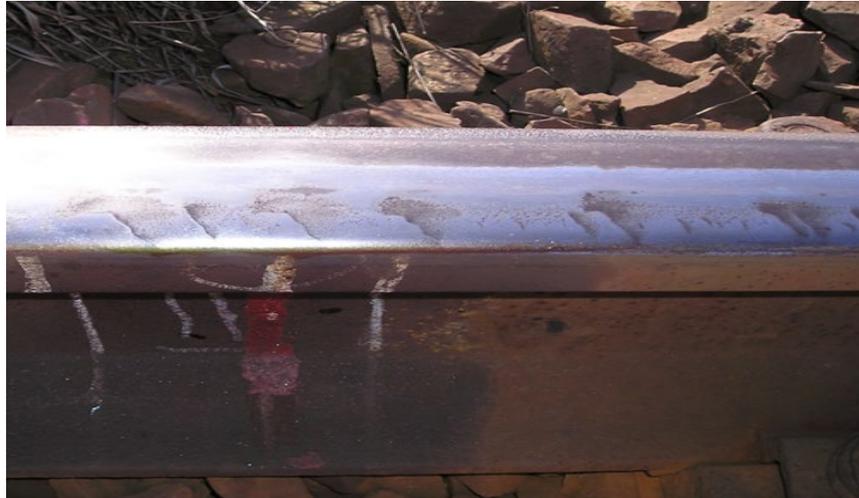
The head checking defect (H-C) most often appears on the inner edge of the head of the outer rail, arranged in arches. It arises in places where the largest dynamic impact occurs (centrifugal force). It also appears on the lateral edges of railways in a straight track and at crossovers. It looks like small, parallel gaps with varying intervals. The distance between the gaps varies depending on local conditions and the type of steel the rail is made of, ranging from 1 mm to several cm. Defects of this type are difficult to detect, due to the promotion of them, among others, in areas a few millimeters below the rolling surface. The short distance of the ultrasonic wave through the material and the weak reflections make detection of this type of defects difficult [4].

Fig. 1 Headchecking - rail under operating conditions

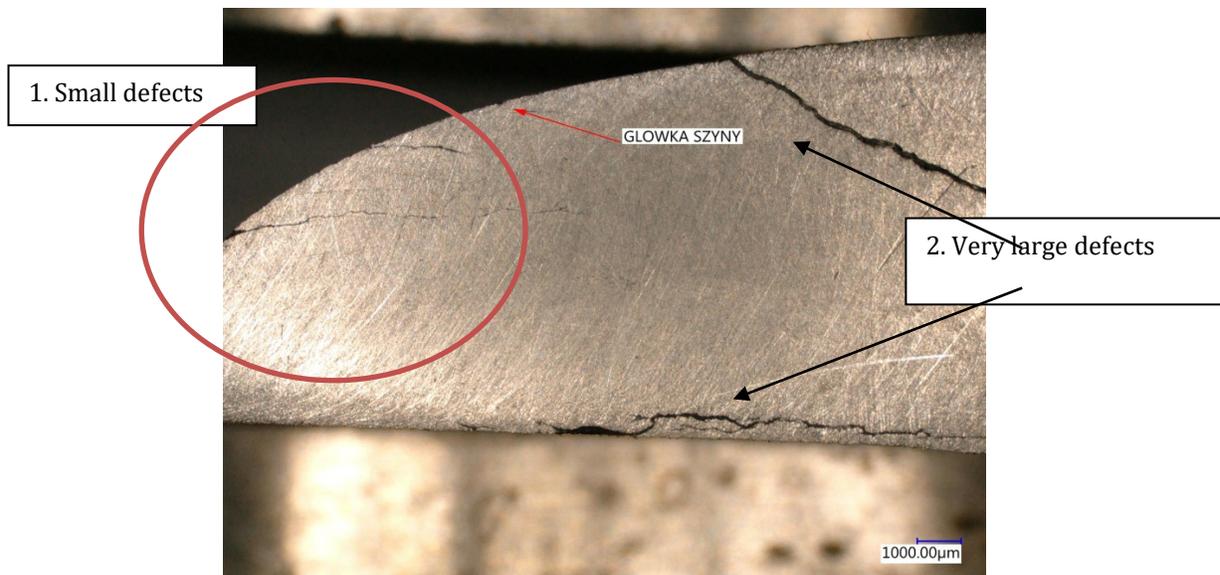
Fig. 2 Head checking occurring in the rail head - cross section (microscopic observations).

Observations and measurements in a plane perpendicular to the rail cross section presented in Fig. 2, shows two cracks reaching up 10 mm, as well as four smaller ones in the surface zone of approx. 3 to 5. These photographs highlight how dangerous this type of defect is, because the complex crack net with significant propagation may lead to material decohesion in a short time.

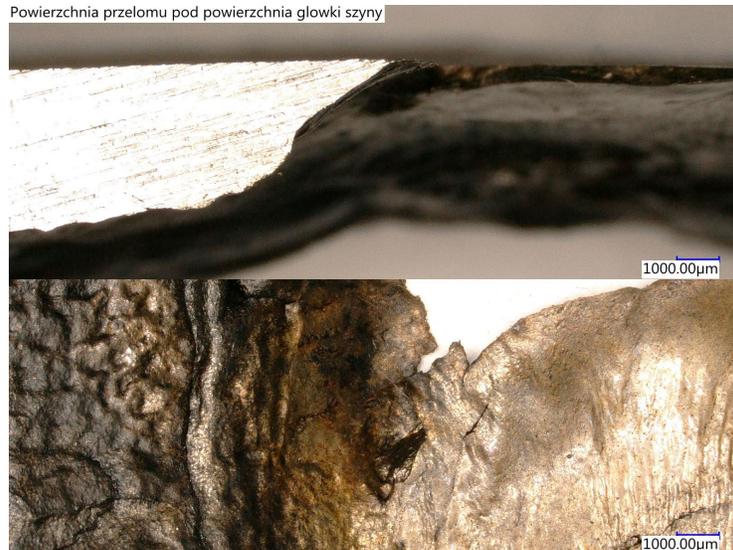
Fig. 3 Head checking defects occurring in the rail head - cross-section (top) - destruction zone under the surface of the rolling zone approx. 2 mm (microscopic observations) - (bottom).

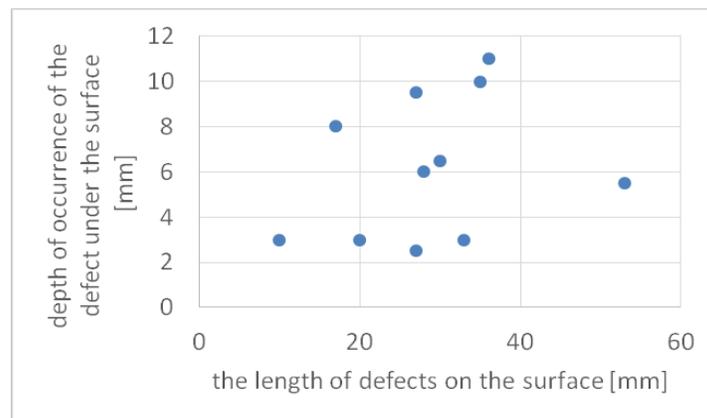
Based on the CT observation, the dimensions of the head-check defect on the surface and the depth of their retention were assessed. These quantities were characterized on the graph – Fig. 6.

Fig. 6. Relationship between the depth of the crack and its length on the surface [own source]

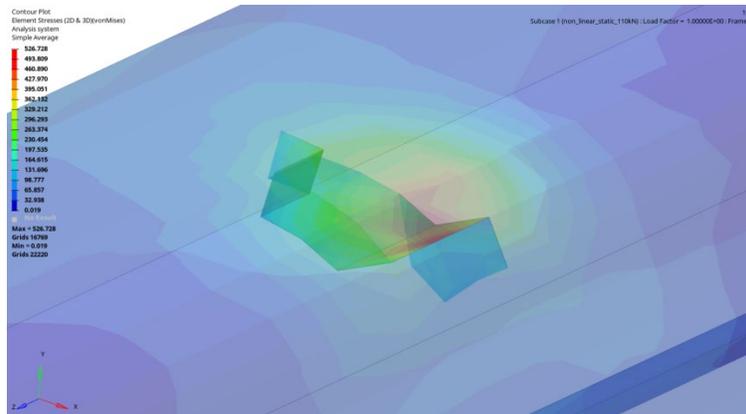
Fig. 8 View of the 60E1 rail with modeled head-check defects (see transparency view).

FEM analysis showed that for the same simulation assumptions, both without and after the introduction of a specific head-check defect, there is a significant increase in plastic deformation in the defect area, and thus a significant increase in stress. These calculations indicate that any contact of a freight wagon wheel (with a load close to the permissible load) causes crack propagation.
