# Quasi-Active Thermography for Structural Health Assessment of Large Geomembranes

**Keywords:** Quasi-Active Thermography, Structural Health Monitoring, Geomembrane, Floating Covers, Sewage Treatment Plant

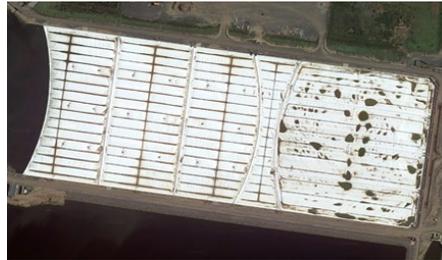
*Figure 1. Aerial view of floating cover in western plant treatment*

greenhouse gases from being released to the atmosphere. There are several large floating covers located at Melbourne Water's Western Treatment Plant (WTP) at Werribee, Melbourne, Australia. These floating covers are made out of 2 mm thick high-density polyethylene (HDPE) material and cover an area of 470 m × 170 m (refer to Figure 1). Approximately 65,000 m<sup>3</sup> of biogas per day is harvested from these covers, which is used to generate 7 MW of renewable energy per day [1].

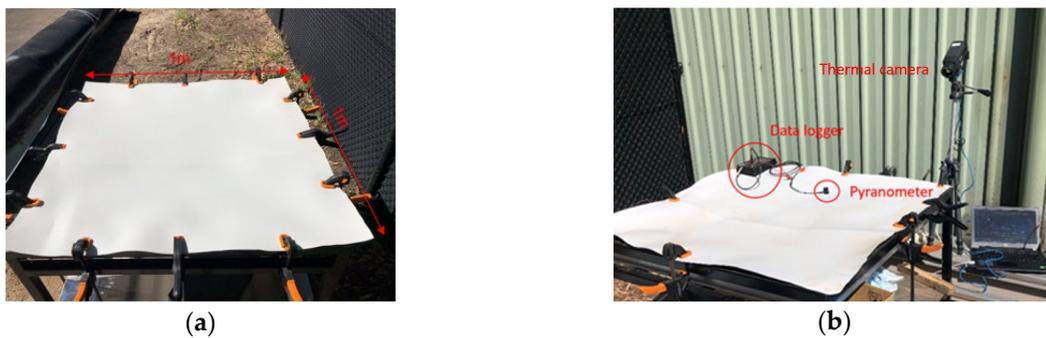
**Figure 2.** (a) HDPE geomembrane specimen (b) Experiment set up of quasi-active thermal imaging

The IR emissivity spectrum of HDPE geomembrane was measured using Fourier-Transform Infrared (FTIR) spectroscopy, which indicated that the HDPE geomembrane is suitable for infrared thermography. The HDPE geomembrane specimen (1 m × 1 m x 2 mm thickness) was clamped onto the aluminium test rig, as shown in Figure 2(a). An Apogee SP-110 pyranometer [12] was installed on the specimen to monitor the irradiation of the specimen surface. An A615 FLIR infrared thermal camera [13] which contains an uncooled Vanadium Oxide detector array of size 640 × 480, was placed beside the geomembrane to record the temperature of the surface of the geomembrane. This equipment setup allows continuous monitoring of the power of solar radiation, through which the transient events due to cloud interference (i.e. shading) can be identified and then correlated with the information obtained from infrared imaging over an extended period of time. The infrared imaging during these transient events is studied in detail.

A preliminary test was first conducted by placing the experimental set up outdoors for 1 hour (see Figure 2(b)) in order to identify the transient event and optimise the resolution and time recording parameters. Both solar intensity and thermal imagery was recorded at a sampling rate of 3 Hz over the test period. Figure 3 shows the solar intensity history measured by the

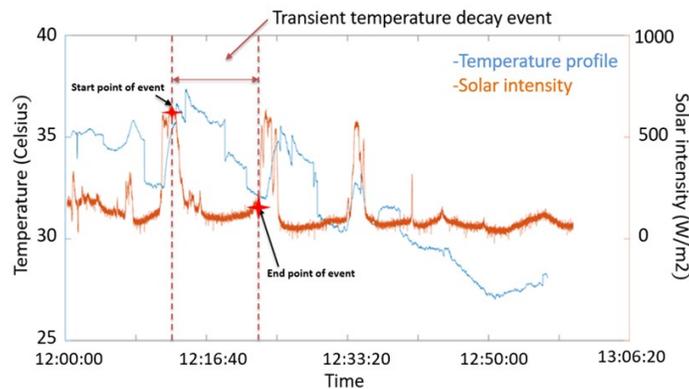
**Figure 3.** Temperature profile on HDPE membrane and solar intensity measured in-site

pyranometer, as well as the temperature variation measured at a point from the thermal imagery, over an observation window of 1 hour. The experiment was conducted on a cloudy day. The pyranometer data showed that the sun was unobstructed by clouds on three occasions during the test period (see Figure 3). During each cloud transition event, associated temperature transients in the membrane are evident. The first event which happened between 12:12:30 and 12:23:20 of the experiment is labelled in Figure 3. The transient event started at 12:12:30 when the pyranometer recorded a change in solar intensity. The temperature transient in the membrane is evident after a few seconds into the cloud-cover event, i.e. the geomembrane temperature increased. According to the pyranometer data, the sun reappeared from the cloud at 12:23:20. A corresponding thermal transient end point was recorded after several seconds into this event (geomembrane temperature increased). Figure 3 suggests that a cloud-cover event can result in a temperature change in the membrane of up to 5° C.

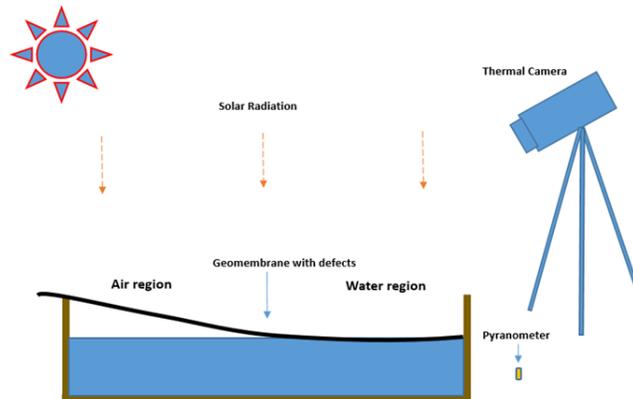
**Figure 4.** Experiment set up of detecting part-through defects on air and on water

As shown in Figure 4, a part of the membrane specimen floats on the water to simulate the liquid sewage region at the treatment plant and the remaining portion has an air gap to simulate the pockets of biogas beneath the floating cover. As shown in Figure 5, a series of part-through defects were created on the underside surface of a  $0.5 \text{ m} \times 1 \text{ m} \times 2 \text{ mm}$  membrane using laser cutting equipment. The dimensions of these defects are shown in Table 1. Defects number 1, 2, 5 and 6 were located in the air region, and defects number 3, 4, 7 and 8 were located in the water region. The experiment was taken outside for 1 hour and exposed to multiple cloud shading

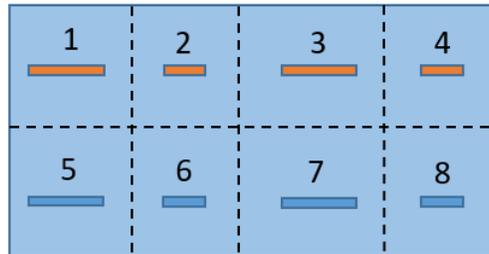
**Figure 5.** HDPE geo-membrane with different dimensions of under surface scratch damage

*Table 1* Details of artificially created damages in each region on the membrane

Defects number	Defect length (cm)	Defect width (cm)	Defect thickness (mm)
1	10	1	1
2	5	1	1
3	10	0.5	1
4	5	0.5	1
5	10	1	0.5
6	5	1	0.5
7	10	0.5	0.5
8	5	0.5	0.5

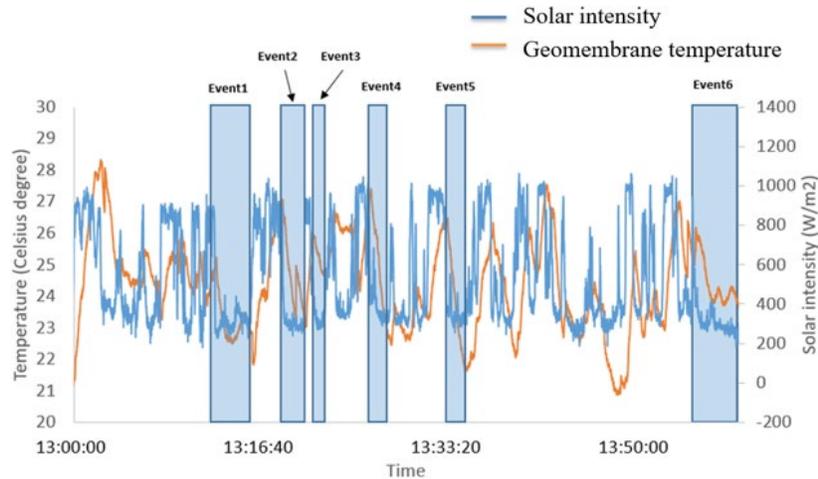
**Figure 6.** History of temperature evolution and solar intensity with 6 highlighted transient events

events. Figure 6 shows solar intensity in these regions decreases abruptly and results in thermal transients in the membrane material. As shown in Figure 7 (a), the regions of air and water contact are readily distinguished in the raw thermal image. The higher thermal resistance of air compared with water resulted in a local temperature increase relative to the part of the membrane resting on the water surface. The right section of the test specimen is located over the water region. The heat absorbed in the membrane in this region is transferred efficiently into the water which has a higher specific heat than air, resulting in a lower temperature relative to the left section. Using the raw thermal image only defect number 1 and 2 which have the largest depth and width can be identified, whereas the defects in the water region could not be readily detected.

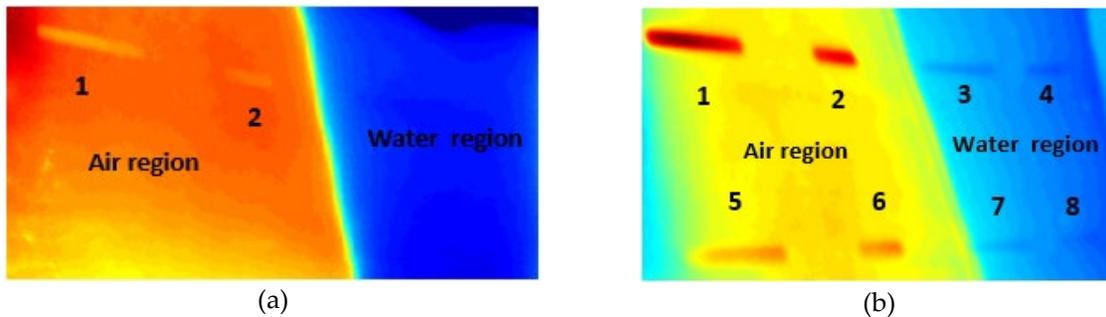
**Figure 7.** (a) Raw infrared thermal image (b) processed thermal image with Eqn (1)

The temperature variations in thermal imagery corresponding to the transient events were processed using Eqn 1. The results obtained are shown in Figure 7 (b). It can be seen that all the defects can now be clearly identified, and the profiles of defects in the air region are clearer. Defects in the water region can be detected, but due to heat being more easily absorbed by water, the profiles are not as clear as those in the air region. In addition, the profiles of defects 5-8 which have 0.5 mm defect depth are not as clear as the profile of defects 1-4 which have 1 mm defect thickness.
