Innovation and Resilience in the Redevelopment, Restoration and Digitalisation Strategies of Architectural Heritage

Keywords: Valorization, Architecture, Restoration, Resilience, Sustainability

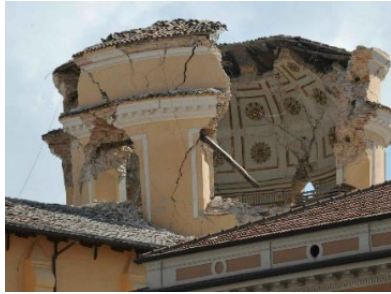
Fig.3. Church of S. Maria del Suffragio, Aquila, Italy. Seismic failure of the dome. [11]

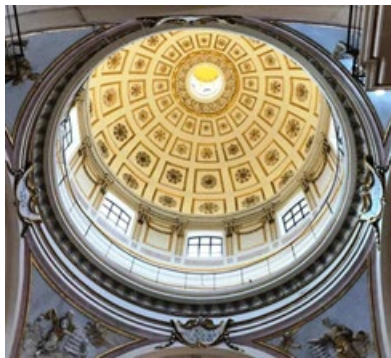
Fig.4. Church of S. Maria del Suffragio, Aquila, Italy- Dome restoration. [12]

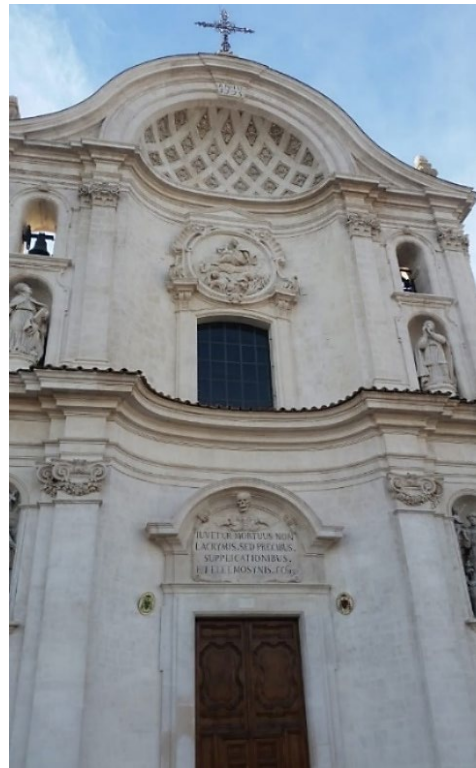
Fig.5. Church of S. Maria del Suffragio, Aquila, Italy, Façade restoration with work completed. [12]

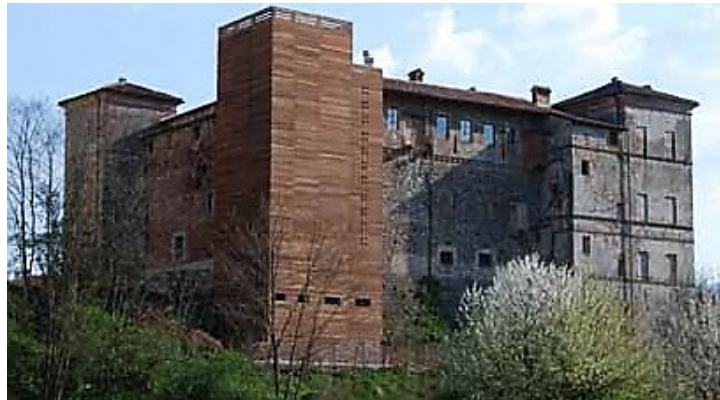
Fig.6. Saliceto Castle, Cuneo, Italy. North-East view, restoration with reconstruction of the tower. [16]

The partial reconstructions sometimes respect the continuity and assonance of colours, materials, configurations and sometimes continuity with pre-existing construction techniques in the walls, highlighting the innovative quality of the restoration process and in which for structural consolidation, compatible micro pilings and plinth systems are often adopted from which to begin the partial reconstruction. For this purpose, in the thirteenth-century castle of Saliceto in Cuneo, Italy, (Fig.6), the [16] eastern tower known as the technological tower (Fig.7) was rebuilt on its original form, totally destroyed and according to criteria above all of distinguishability in the conservative restoration with adaptive reuse as a new public building, with a steel structure and ventilated walls covered in cedar wood panels, compared to the remaining three towers and the entire monument in load-bearing brick masonry. It contains the new thermal power plant.

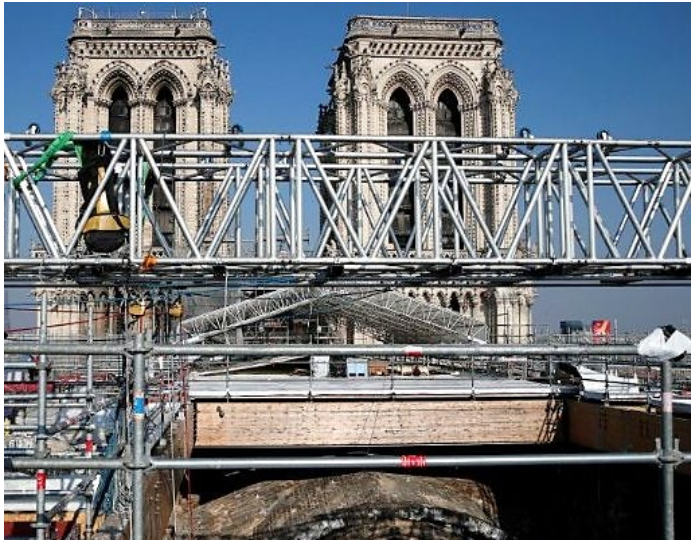
Fig.8. Notre Dame Cathedral, Paris. Restoration work. [17]

Among the conservative architectural restorations, the reconstruction work on the roof of the Gothic cathedral of Notre-Dame in Paris (Fig.8) and the spire, destroyed by fire, are noteworthy. The cathedral was restored in 1844 by the French architect Viollet le Duc, presenting the plan with a central nave divided into three floors, and two side naves, the central one is approximately 37 m wide, and 125 m long, 32 m high. with columns supporting pointed arches on which the hexapartite vaults originate. Today's conservative restoration underway is based on stylistic choices that recall the original project and materials in wood from centuries-old oaks, originating from French forests, with the reuse of the pre-existing iron reinforcements in the cathedral, in types of iron staples on the top walls of the south nave, in a, instead in b, iron braces of the monolithic columns of the nave, in c iron braces in the choir gallery. (Fig.9. a,b,c).

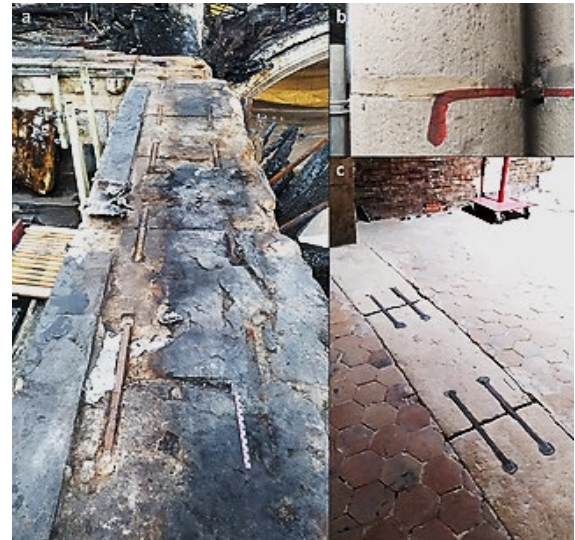
Fig.9. Notre Dame Cathedral, Paris. Detail of iron staples: a. south nave, b. monolithic columns nave, c. choir stand.[18]

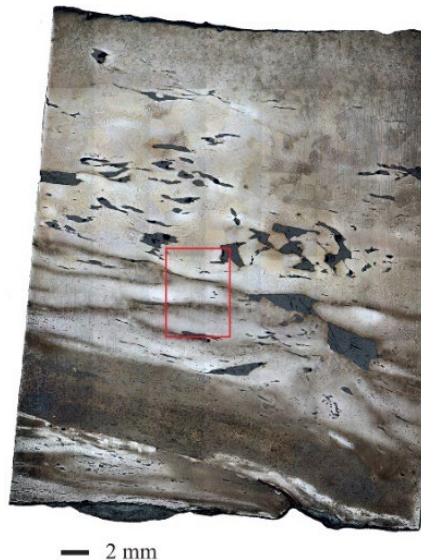
Fig.11. Notre Dame Cathedral, Paris. Oberhoffer on sample NN9-T with mesoscopic microscopic changes in P content, with highrate in lighter areas. [18]

lag inclusion and porosity (NS106-T1). c. Ghost structure and different grain size of ferrite (NS8-L), d. Lightly carburized area with Widmanstätten ferrite and small SI (NS106T1), e. Area cemented with pearlite and ferrite from Widmanstätten (TRIB01S). Instead mesoscopic and microscopic variations result with Oberhoffer on the NN9-T sample (Fig.11).

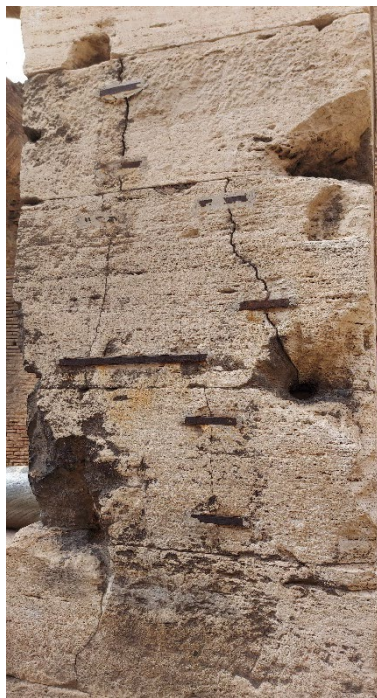
a

Fig.14. a. Structural lesions. [23] Fig.15. b. Structural lesions with gaps in concrete. [23]

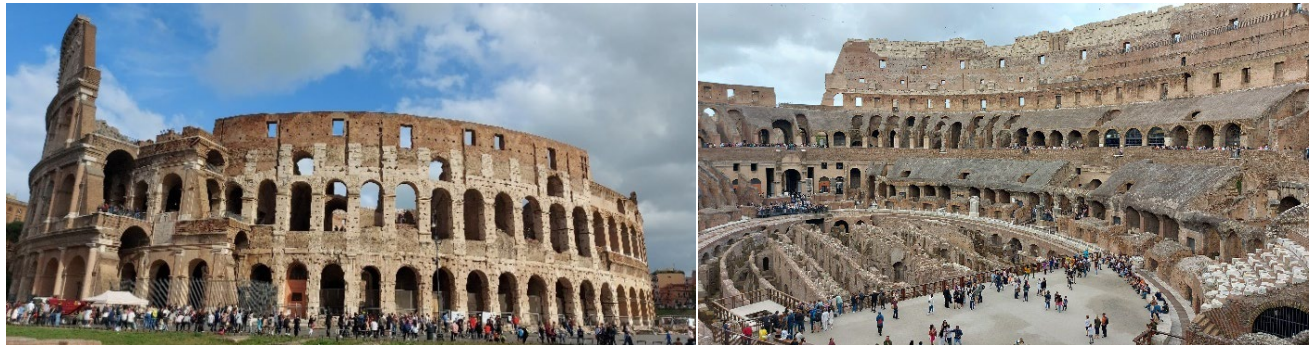
Flavian Amphitheater-Colosseum in Rome, Italy :

Fig.17. Perspective view. [30]

Satellite interferometry also allows you to monitor the structural deformations and instability of buildings at risk of seismic, hydrogeological, erosion, etc. and has been used for the 400 European UNESCO sites, such as the Colosseum in Rome (Fig. 17, Fig. 18)) with PROTHEGO (Protection of European Cultural Heritage from GeO-hazards) in addition to the European JPICH PROTHEGO project, for Pompeii, in the center of Rome, etc.

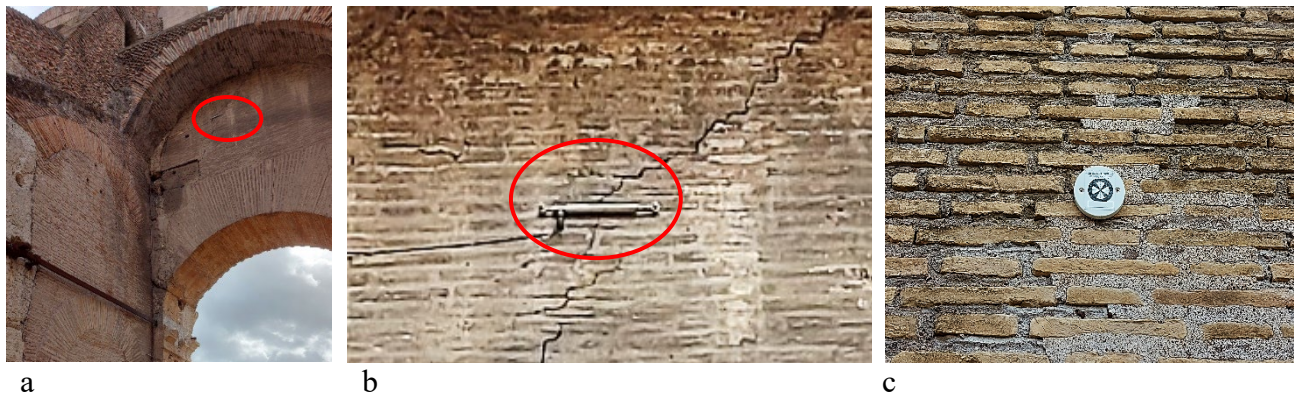
Fig.19 (a, b, c) - a. Crack meter on masonry cracks, b. Crack meter detail, c. Geogrà digital system. [30]

Furthermore, we resort to the use of wireless sensor networks, various intelligent technologies such as BOX-IO etc., on an IoT platform and data analysis, and a web platform and cloud space, which allow us to monitor humidity and temperature levels in a interoperability of eco-systems. For non-invasive structural monitoring, crack meters are adopted in multiple interventions worldwide and as in the Flavian Amphitheater in the archaeological park of the Colosseum in Rome where digitalized surveys with 3D laser scanners have been started (Fig.19,a,b,c) , in which the monitoring system is made up of the Sypeah web platform (System for the Protection and Education of Archaeological Heritage) created in collaboration with the ASI (Italian Space Agency) initiatives of the Italian national body MIBAC of the Ministry of Culture, for a informative webGIS for both monitoring and management and scheduled maintenance, in a collaboration project with research institutions and universities [29]. Also the IBC (Institute for Artistic, Cultural and Natural Heritage) and CNR-ISAC, adheres to these initiatives for the monitoring and management of cultural heritage. In monitoring systems with the crack meter instrument, the possible evolution of crack displacements and instability, etc. is detected. indicating over time, the variation in distance between two initial points of the disconnection, lesion, and more.

A multi-probe triaxial tiltometer and accelerometer of the monitoring system are connected to analogue communication nodes, consisting of wireless sensors that can be managed remotely, through a Cloud platform with information directly on the online 3D model, about the structures, environmental findings, and more.

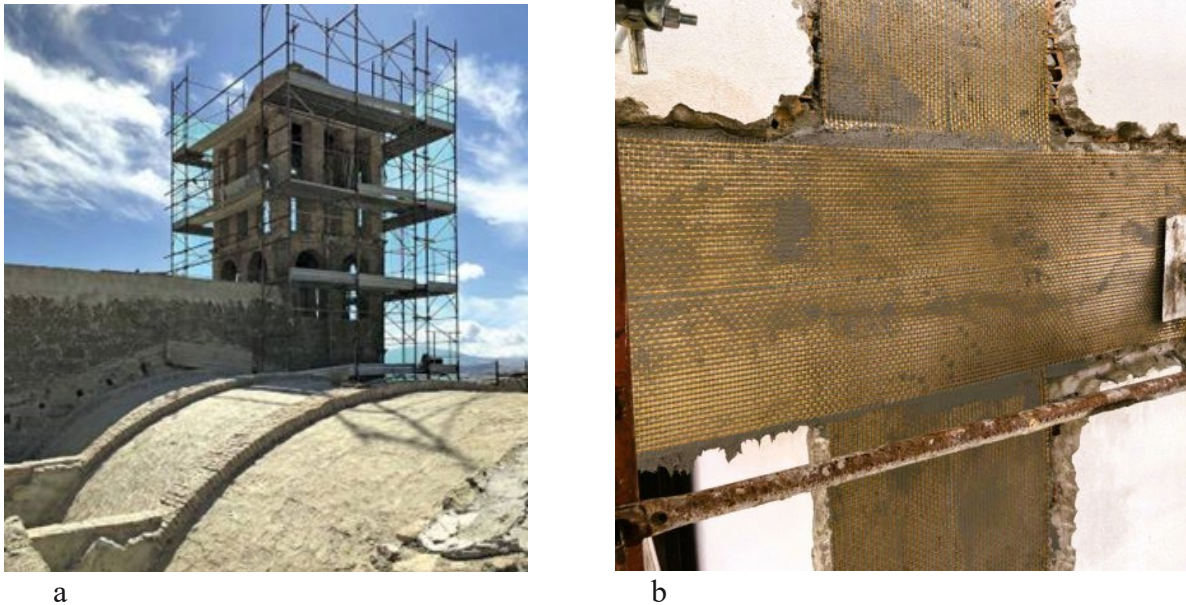
Fig. 25 (a,b) . Application of FRCM on vaults: a. [41], b. PBO and carbon long fiber reinforcement FRCM on reduced section concrete structures (such as floor joists) with 105 g/m² unidirectional PBO mesh and MX-PBO Concrete inorganic matrix. [42]

Therefore at a procedural level in a restoration project both for structural consolidation and for seismic and gravitational loads through the use of FRCM (Fig.25), of good chemical-physical compatibility with masonry and concrete substrates, there are also these European and national regulations in force with indicative intervention strategies for the design, execution and control of historical artefacts on the technological system of the building. In particular on the classes of foundation, elevation and containment load-bearing structures through reinforcements to masonry structures (arches and vaults, confinement of masonry pillars, floor and top curbs, wall panels), instead reinforcements on concrete structures (nodes between /pillar, confinement of pillars, floors, flexural reinforcement of beams, pillars and floor joists, shear reinforcement of beams and pillars, anti-overturning of infills, reinforced concrete partitions, of bridges and more).

For example, for anti-seismic reinforcement on the intrados and also on the extrados of vaults or masonry arches to increase tensile strength and contract the opening of the hinges, plating with bands of nets or unidirectional fabric, in carbon fibre, is used galvanized with very high resistance, and with hydraulic lime-based mortar, while for floor kerbing an external kerbing is applied with fabric bands that surround the building or with reinforced masonry top curbs through the application of horizontal mortar joints of FRCM reinforcement networks. For concrete structures and small sections such as floor joists, PBO mesh with a high-performance inorganic matrix is applied, (Fig.25. a,b).
