Object Detection Method for Automated Classification of Distress in Rabat's Built Heritage

Mediterranean Architectural Heritage - RIPAM10	Materials Research Forum LLC
Materials Research Proceedings 40 (2024) 358-362	https://doi.org/10.21741/9781644903117-37

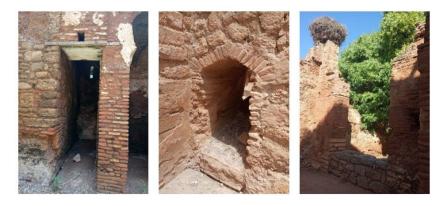
Fig. 1: sample images of Chellah monument

The dataset employed in this study includes images manually taken at Chellah using a Canon 700D camera. A total of 120 images is at your disposal, each showcasing unique dimensions influenced by the diverse scales of the captured scenes. These images specifically concentrate on various forms of impairments observed at Chellah, encompassing delamination, cracks, lichens, rising damp, spalling and partial collapse. Fig. 1 presents some samples of this dataset.

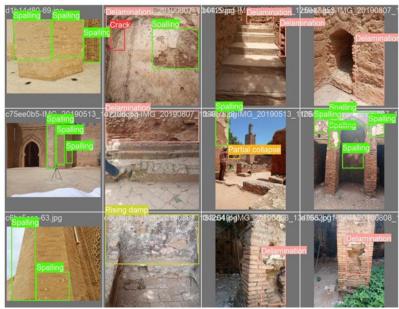
Fig. 3. Illustrative instance showcasing predicted bounding boxes utilizing the YOLOv5 model.

To verify the outcomes produced by the model, Fig. 3 displays the results generated by the model in identifying bounding boxes for each damage type. Based on these findings, one can infer that the model demonstrates an impressive capacity to distinguish among the various deteriorations in Chellah. This affirms its effectiveness in accurately identifying and precisely locating different anomalies across the surveyed surfaces.
