Evaluation of Residual Stress Effects in Aft Pressure Ring Frame of a Royal Australian Air Force P-3C Maritime Patrol Aircraft

Abstract. Aft pressure bulkhead ring frames on the RAAF P-3C Orion aircraft are being replaced due to in-service fatigue cracking. Installation of the new 7075-T6511 extrusion L-section circular frame requires local adjustment of the included angle at various positions around the circumference. The adjustment should be carried out under a controlled temperature in the range of 135 – 160° C. However in some recent cases the temperature was either not well controlled and/or was below that range, raising concerns about the potential for adverse residual stresses in a region already known to be susceptible to fatigue. This paper details an investigation including 3-D non-linear finite element (FE) modelling and X-Ray diffraction based residual stress measurements on representative frame segments. The FE modelling was performed with NASTRAN using 3-D solid elements. Plastic behaviour was modelled using a Ramberg-Osgood approach. The X-Ray diffraction was performed using a Proto iXRD Combo instrument with a Cobalt X-ray source and a rectangular aperture (1.0, 1.

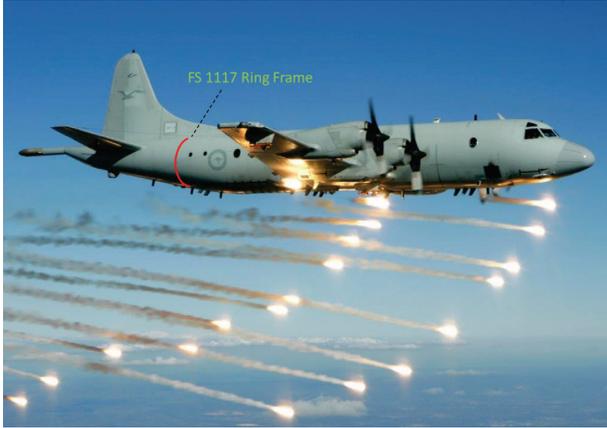
Figure 1 : Aft pressure bulkhead location at FS 111, RAAF AP-3C aircraft

The aft pressure bulkhead structure at FS 1117 on the P-3 Orion aircraft, Figure 1, includes an approximately “L” shaped forward frame segment, Figure 2. The frame, manufactured from 7075-T651 alloy extrusion has a nominal included angle of 100°. Due to cracking which has occurred in service at the location of interest shown in Figure 2, the frames are being replaced on some RAAF aircraft. During installation of the new frames, the included angle needs to be adjusted in some areas. In the upper region of the fuselage the angle is tightened to about 94°, and in the lower end the angle is increased to about 102°. The angle adjustments are performed mechanically as shown in Figure 3 with locally applied heating [1]. The temperature range for the heating should be carefully controlled and thermocouple measurements are to be taken to ensure that the temperature range is controlled to the range 135 – 160° C. In some cases however, thermocouple measurements were not taken and it was thought that the hand forming in those cases may have occurred at a temperature below the specified range.

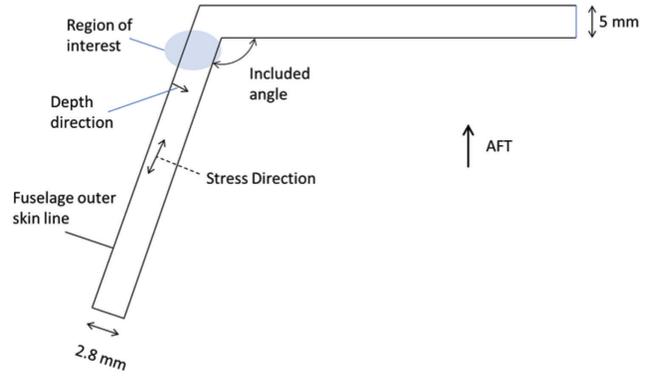
Figure 2 : Cross section of forward ring frame of FS 1117 aft pressure bulkhead

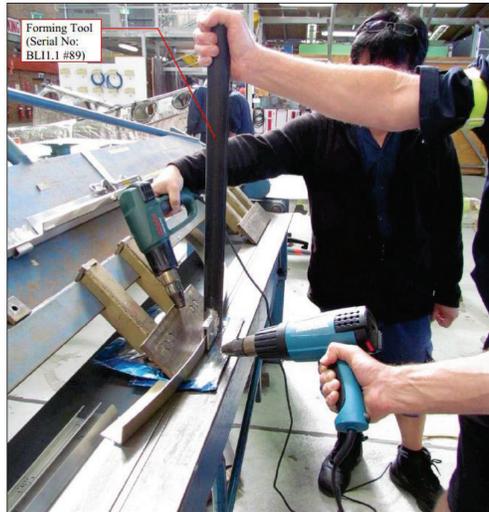
Figure 3 : Hand forming process for FS 117 forward ring frame included angle adjustment

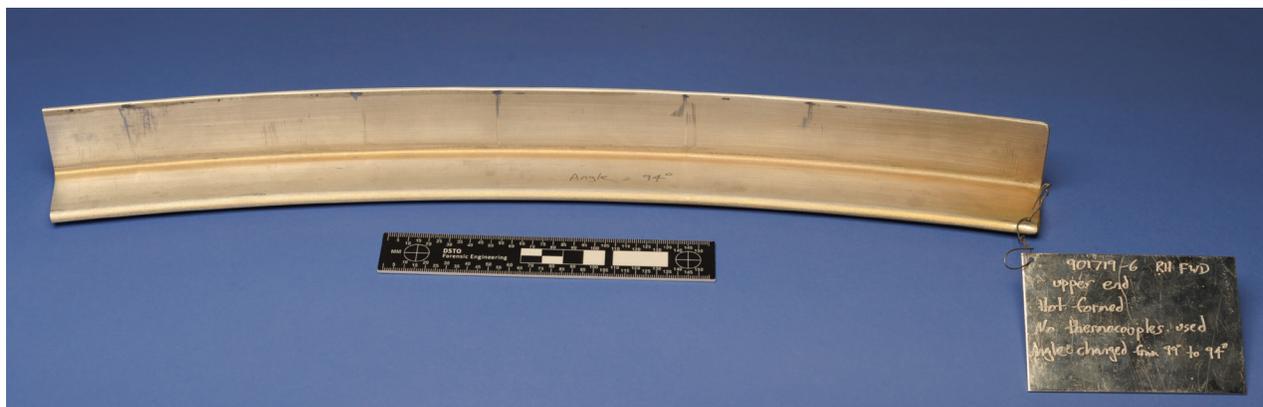
The specimens provided have an arc length of about 500 mm. A typical example is shown in Figure 4.

Figure 4 Typical FS1117 ring frame specimen provided for investigation

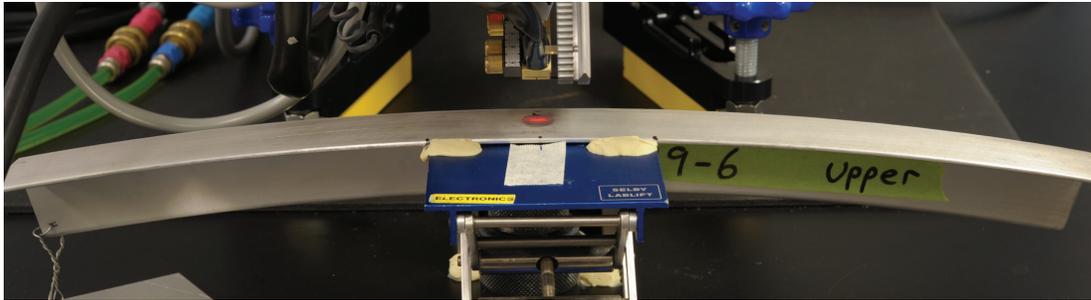
X-Ray diffraction details. X-Ray diffraction measurements were performed with a Proto iXRD Combo with a Cobalt X-Ray source and a rectangular aperture (1.0, 1.5 or 2.0 x 5.0 mm). Profile measurements into the depth were made wherever possible. Depth measurements were performed by taking progressive electro-polishing cuts using the Proto system. Most measurements were taken from the outer surface, but some readings were also undertaken where possible on the inner surface. The typical set-up for an outer surface measurement is shown in Figure 5.

Figure 5 : Typical set-up for outer surface measurement

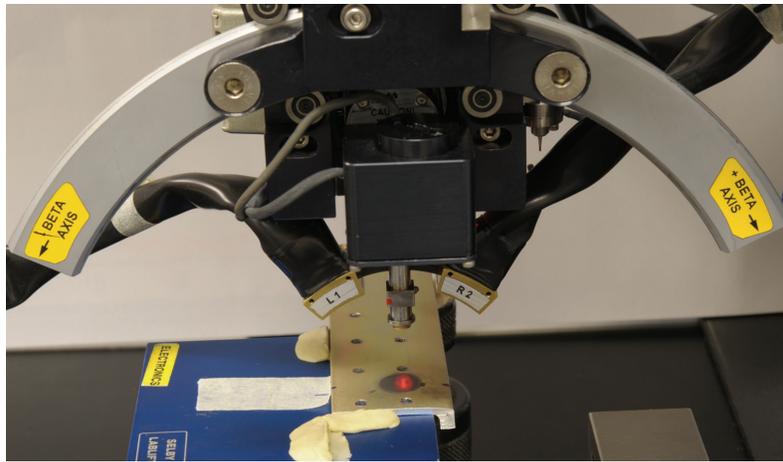
When measurements were taken on the inner surface it was necessary to cut away part of the thick flange to ensure that the X-Rays were not shielded from the region of interest. A sample with the flange cut away is shown in Figure 6

Figure 6 : XRD set up detail showing case where thick flange is cut away to allow inner surface measurement

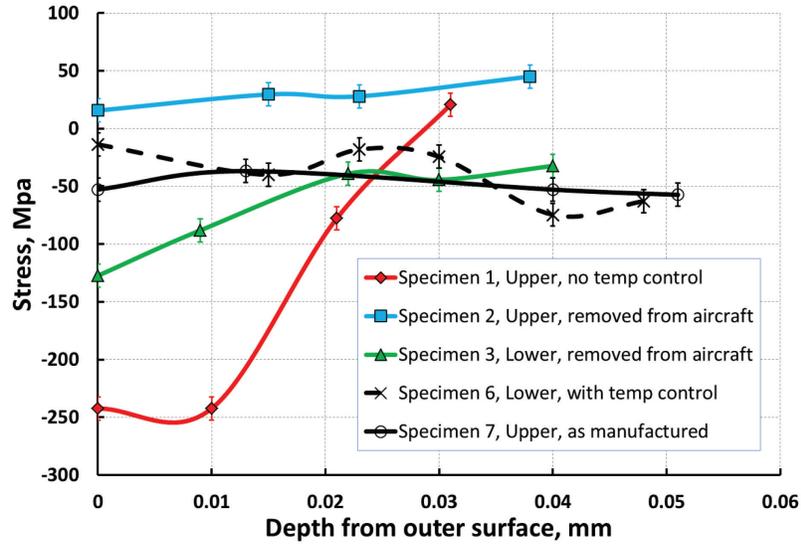
The residual stress results into the depth from the outer surface are detailed in Figure 7. In addition, the following surface only results were obtained for the residual stress measurements:

Figure 7 : X-Ray diffraction residual stress measurements with depth

The peak residual stress in the tested ring frames were found to be mostly low, i.e. less than 50 MPa in magnitude. The most significant residual stress measured was about -250 MPa (compression) at the outer surface on sample 1 which was at the RH upper location (no temperature control) with a nominal angle change from 100° to 94°. In comparison, the FE result for a nominal

The highest absolute stress measured in any sample was a tensile stress close to +50 MPa at a depth of about 0.04 mm in Specimen 2, which was removed from the upper location in a service aircraft A09-662. The final angle was measured to be 94-95°. Being the upper location, like Specimen 1, the nominal condition would be decreasing the angle from 100 to 94°. In this case it appears likely that the angle change was therefore in the range 5-6°, which is less than for Specimen 1 where the nominal change was 7-9°. It is therefore consistent that Specimen 1 would exhibit larger magnitude residual stress than Specimen 2.

It is important to note that the measured residual stress even in new ring frame segments with no angle change were around -50 MPa (compression) at the outer surface (Specimens 7 and 8). This is a measure of the typical residual stress in the as-manufactured condition, so this gives an indication of the possible starting point for residual stress in these frames.
