A Cause for Cracking of Head-Check Rails

Abstract. The paper presents the reasons for the emergence of one of the main defects of railway rails, such as cracking, and factors affecting its increase. It was found that vehicle cooperation with the rail and the forming of the rolling surface caused by the load, as well as the resulting rail stresses caused by the dynamics of rolling stock are the cause of the head-check of the rails. The influence of impact resistance on rail cracks in the occurrence of these defects is also presented.

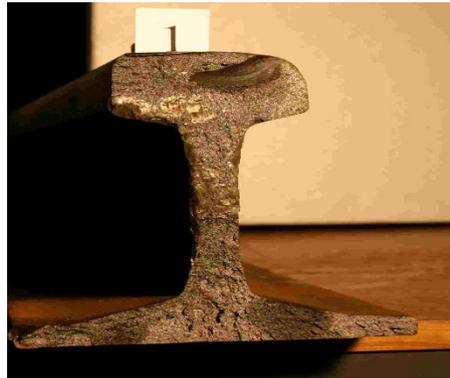
Fig. 2. A defect head check with cracking coming out.

One of the disadvantages of rails, which can appear during operation and have a negative impact on traffic safety, is the head check as shown in Fig. 1 and Fig. 2. It is a defect that arises on the running surface of the rail head and is characterized by the parallel arrangement of cracks at a specific angle to the direction of travel of the train. The defect arises mainly on the curves of the tracks near the edge of the rail head, then passing to the rolling surface. It was found that this defect also occurs on straight sections, however only where the rails are heavily loaded.

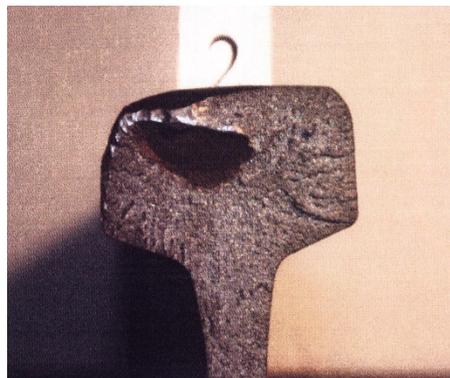
Fig. 3. A defect head check was created inside the head of the rail.

Therefore, as a result of the rail – wheel contact and crush of the running surface of the rail caused by a long exploitation in the track, the resulting crack becomes the beginning of the crack propagating inside the rail. It is then a fatigue type defect. It is visually detected. In contrast, fatigue defects of the rail with dislocation, vacancy and stress mechanisms, are created inside the head of the rail. They do not come to the surface and are detectable by ultrasonic testing [2]. At the same time, due to the difficulty in detecting this type of defect in the rails (Fig. 3), it can affect the safety of rail transport.

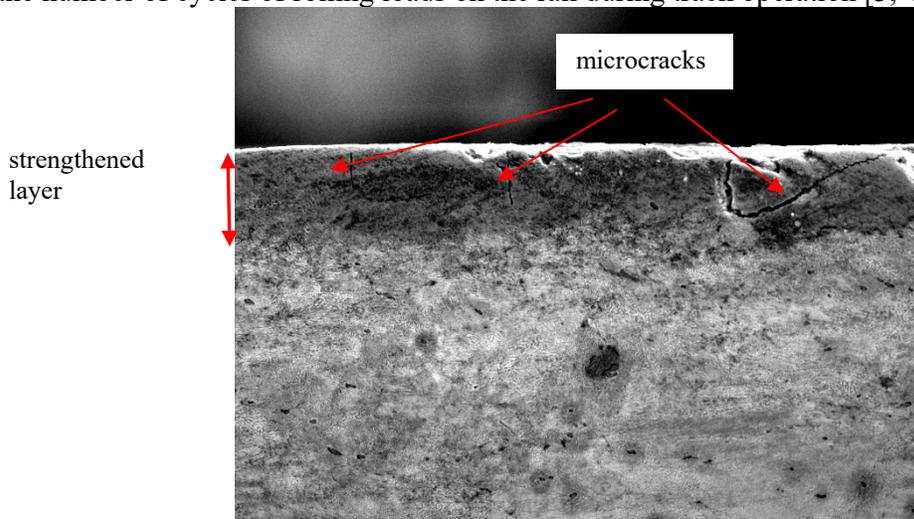
Fig. 4. Strengthened layer of the running surface on the cross-section of the rail head (SEM, 500x).

Strengthening of the rail surface is progressive as the number of load cycles increases. Then strengthened zones are formed, passing from the surface deep into the material. The resulting structure is characterized by a structure similar to the layered system (Fig. 4, 5). The layered system is created by burnishing the material in the direction of the train. Grains in fortified layers are laid at a certain angle to the surface, depending on the material structure. As a result of increasing load cycles, the surface layer of the head first undergoes elastic deformation, then gradual wrinkling and strengthening. It is a phenomenon of plastic deformation that reaches the limit of material tensile strength. After exceeding this limit, the surface layer ruptures and microcracks arise [7, 8]. Cyclical structural stresses are an additional factor. This is the first stage of creating a defect in the rail head check. The further development of microcracks runs through the fatigue mechanism and is dependent on the number of cycles of rolling loads on the rail during track operation [3, 4].

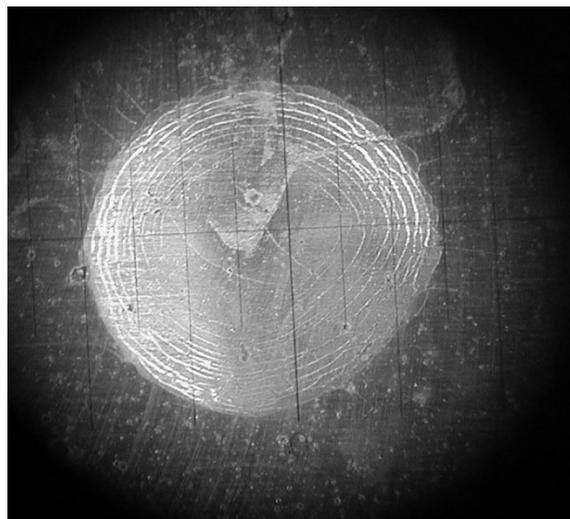
Fig. 5. Imprint of hardness with a 10 mm ball on the rail surface with a visible trace of crushed layers.

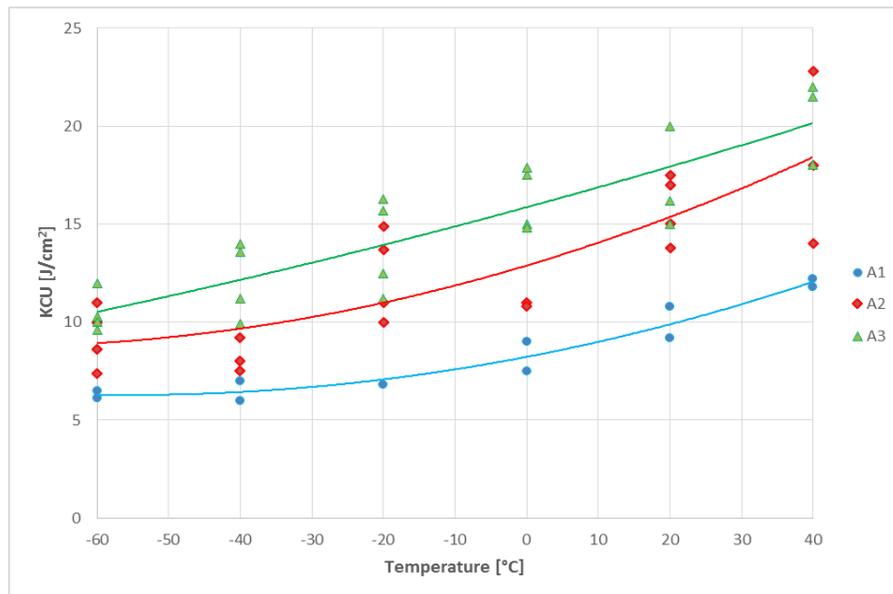
Fig. 6. The impact resistance on the R260 rails.

Due to the increased number of rail cracks in winter and the need to replace them on the route, impact tests of rails were carried out at a temperature of -60°C to 40°C (Fig. 6), with a temperature increase of 20°C .

As a result of testing the impact strength of the rail material at subzero temperatures, no sudden reduction of impact strength or a clear brittleness threshold in the tested temperature range from $+40^{\circ}\text{C}$ to -60°C was observed.

Fig. 6 shows that, after 30 years of exploitation, the material of the A1 sample rail, has lower impact strength in the entire temperature range, proportionally lower in relation to the impact resistance obtained from the other rails of the A2 and A3 samples. The difference in impact resistance of rails at below zero temperatures is about 40% lower than at temperatures in summer. The size of the impact strength which determines the impact resistance of the material in the case of existing head checks, may indicate the possibility of rail cracks, especially at high fluctuations in the ambient temperature.
