Impact of Decarburization on the Hardness of the Rails Running Surface

MIKŁASZEWICZ Ireneusz^{1,a}

¹ Instytut Kolejnictwa (The Railway Research Institute), Materials & Structure Laboratory, 50, Chłopicki Street, 04-275 Warsaw, Poland

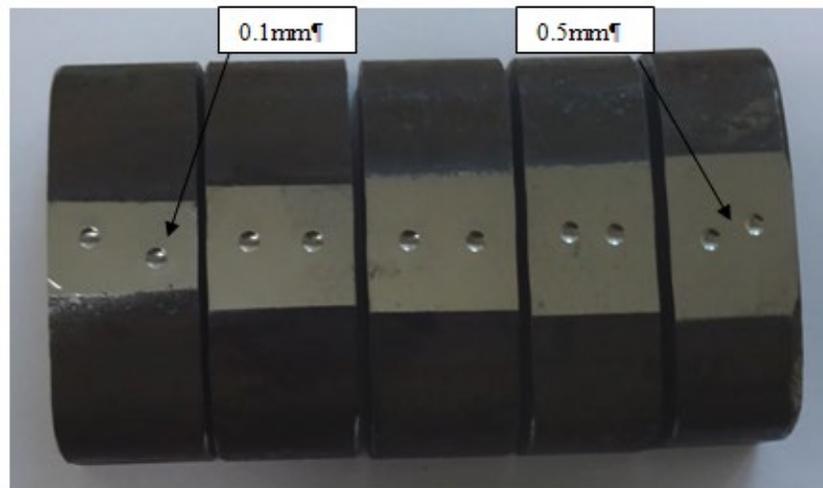
Samples were cut from the rail sections, whose running surface of the rail head was ground from 0.10 mm to 0.50 mm using 0.10 mm increments. HV5 and HBW hardness measurements were made on samples prepared in this way [3]. The prepared test samples are shown in Fig. 5. Then, after grinding, polishing and etching samples in 4% nital, the decarburized layer of the selected rail manufacturer was shown, indicating the lowest and highest hardness.

Fig. 5. C-smelt rails with a ground running surface
