Investigations of the Head Check Defects in Rails

¹Institut Kolejnictwa (The Railway Research Institute), Materials & Structure Laboratory, 50, Chłopicki Street, 04-275 Warsaw, Poland

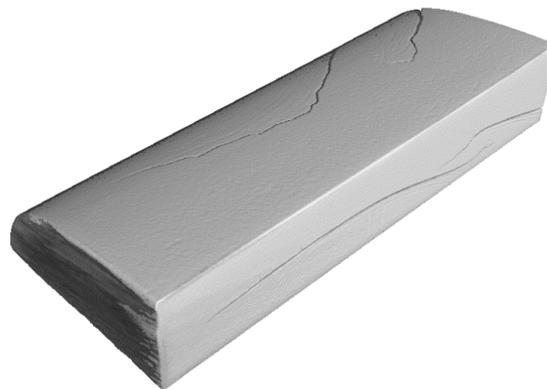
Fig. 4. Visualization of the sample in the editor "myVGL"

Based on the CT observation, the dimensions of the head-check defect on the surface and the depth of their retention were assessed. These quantities were characterized on the graph – Fig. 6.

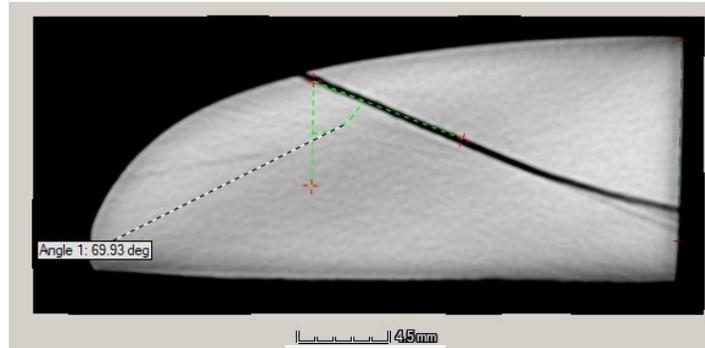
Fig. 5. Visualization of the method of measuring the defect penetration angle.

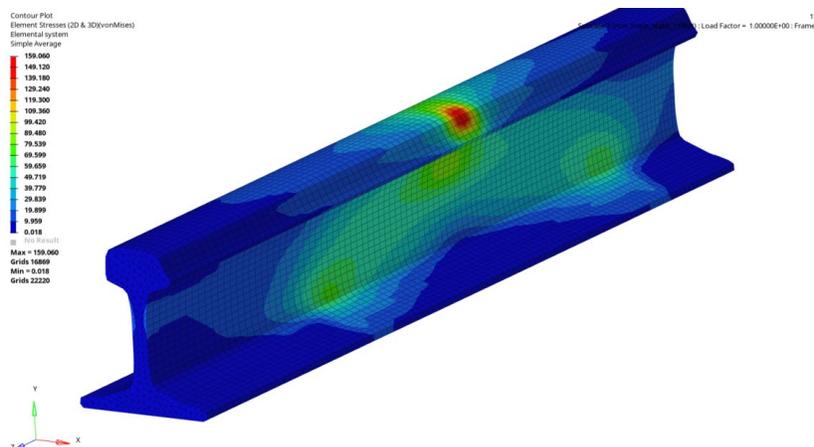
Fig. 7 Distribution von Mises stresses in rail 60E1 rail without defects.

FEM analysis showed that for the same simulation assumptions, both without and after the introduction of a specific head-check defect, there is a significant increase in plastic deformation in the defect area, and thus a significant increase in stress. These calculations indicate that any contact of a freight wagon wheel (with a load close to the permissible load) causes crack propagation.
