Evaluation of the Influence of Laboratory Weathering of Paint Systems used in Rolling Stock on Selected Mechanical Properties

Keywords: Rolling Stock, Coatings, Accelerated Weathering, Xenon-Arc Radiation, Hardness, Resistance to Cupping Test, Adhesion

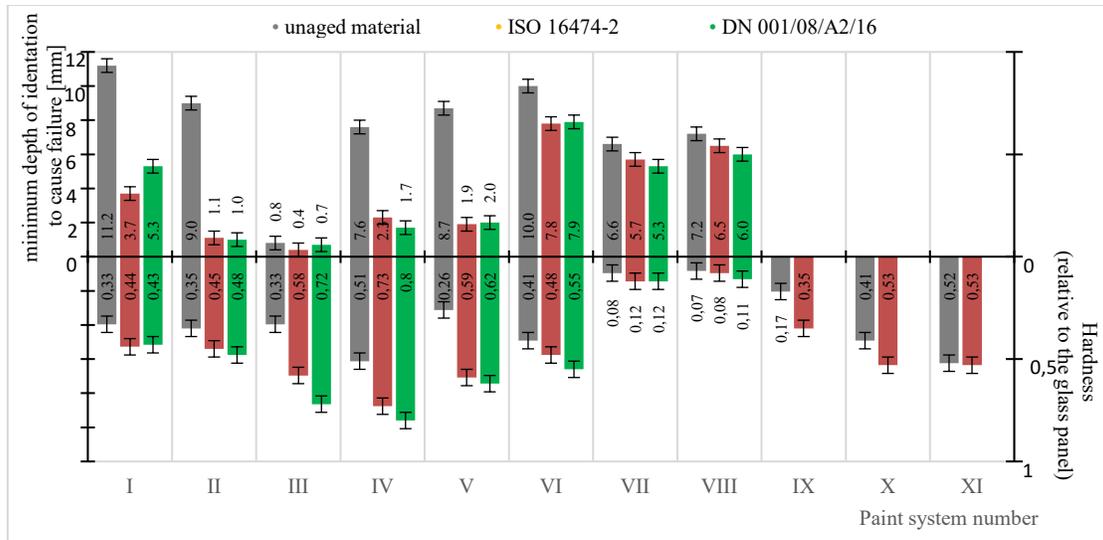
Fig. 1. Graphical summary of the minimum indentation depth causing damage to the coating [mm] according to ISO 1520 [11] and hardness (about the glass constant) determined by the König pendulum damping method according to ISO 1522 [10] for selected tested paint systems.

In the case of tests on resistance to indentation, in most cases, relatively large drops of this parameter after aging were observed; however, some of the systems tested retained their properties at a satisfactory level (systems VI, VII, VIII). Also, in this case, similar results were obtained for both aging methods used, where the average drops in adhesion for all tested systems were 4.0 mm for the ISO 16474-2 method [1] and 3.9 mm for the method according to DN 001/08/A2/16 [2], respectively.

When evaluating hardness, an increase in this parameter was observed in every specimen tested. A more significant increase was observed in the case of aging according to an in-house aging method.

There is noticeable a certain correlation between an increase in hardness (and therefore brittleness) and a decrease in such parameters as adhesion or resistance to indentation – the more significant the increase in hardness, the greater the negative change in such parameters as adhesion or resistance to indentation. A high hardness value is a recommended parameter due to the increase of, among others, scratch resistance. However, other properties of coatings related to their elastic properties to be complete cannot be neglected – as in every case, a compromise solution has to be found.
