Testing of Flash Butt Welded Rail Joints

MIKŁASZEWICZ Ireneusz

Instytut Kolejnictwa (Railway Research Institute), Chłopicki 50, Street, 04-275 Warsaw, Poland

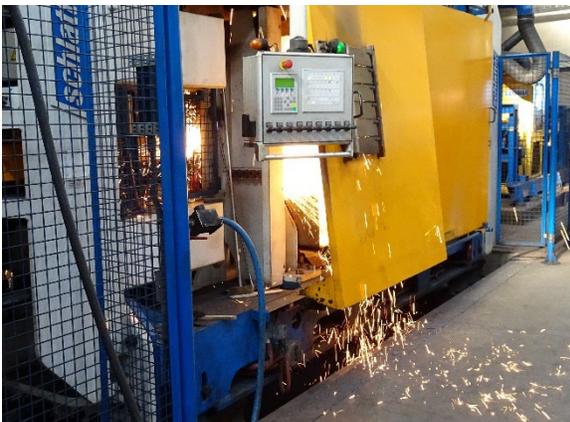
Fig. 1. Stationary rail flash butt welding machine during flashing (Photo: Author)

In addition to rail defects revealed during operation, including hazardous defects of the head check type [4], which arise on the surface of the railhead, then penetrate deep into the material and constitute a dangerous source of cracks, we may also include occasionally occurring defects of rail joints arising in the process of flash butt welding with stationary and mobile welding machines (Fig.1), also posing a potential danger of distribution cracks.

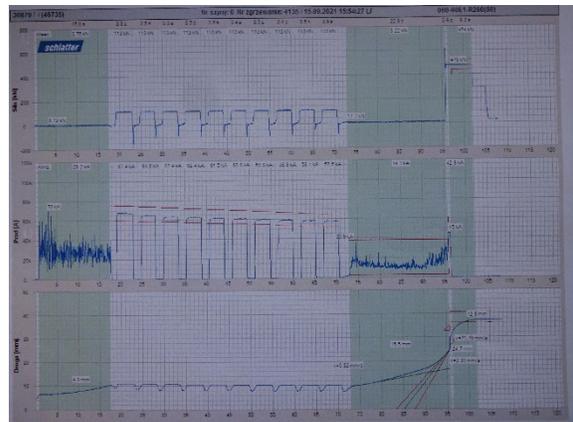
Fig. 2. Flash butt welding parameters of R260 grade rail (Photo: Author)

Rail welding is performed using the flash butt welding method with the process of flashing the surfaces to be joined and subsequent upsetting with force, enabling the front surfaces to be welded [5]. The rail joining process is fully automatic, operating according to computer-controlled programs, depending on the grade and profile of the flash butt welded rails, with a complete registration of technological parameters. An example of the rail flash butt welding diagram for the R260 grade is shown in Fig. 2.

The course of force, current and pre-heating period paths, and flashing and upsetting periods are represented by the corresponding lines in the diagram. Abrupt differences in the above values are visible. This is due to the developed flash butt welding technology. Several times, the flashing period is characterized by the ejection of molten metal due to the formation of current bridges of the emerging electric arc and metal vapor pressure. This results in cleaning and leveling the surfaces of the rails to be flash butt welded and further heating of the ends and upsetting in the final part of the joint flash butt welding process. As a result of joining, the rails are shortened by about 35-45 mm, and the flash butt welding time closes in the range of 80-110 seconds.

The rail flash butt welding diagrams of the R350HT and R400 grades are similar, with a slight difference in the amount of the applied current strength and path.

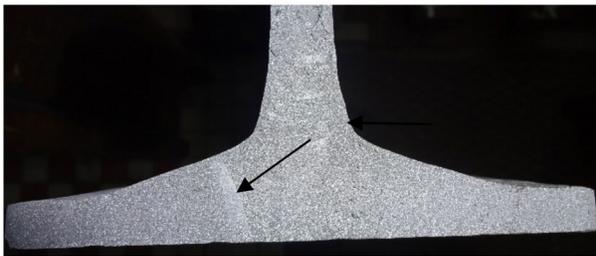
Fig. 3. Dull spots on the fracture of a broken joint (source: author)

Rail joints flash butt welded to the shape of the rails to be joined by straightening and grinding treatment to ensure smooth running. In addition, penetrant, magnetic powder, and ultrasonic tests are used to evaluate the flash butt welded rail joints. However, there are occasional cases of irregularities caused mainly by unforeseeable jumps in the technological parameters of flash butt welding, related, among others, to inadequately prepared rail ends for flash butt welding. This is manifested through the appearance of so-called dull spots in the flash butt welding line. These spots are revealed at the fractures of broken rail joints during bending tests. Fig. 3 and Fig. 4 show instances of dull spots at different locations of the fractures.

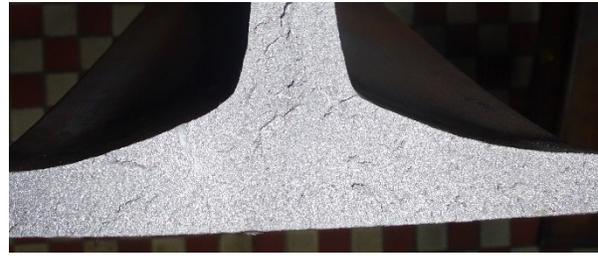
Fig. 4. Dull spots on the fracture of a broken joint (source: author)

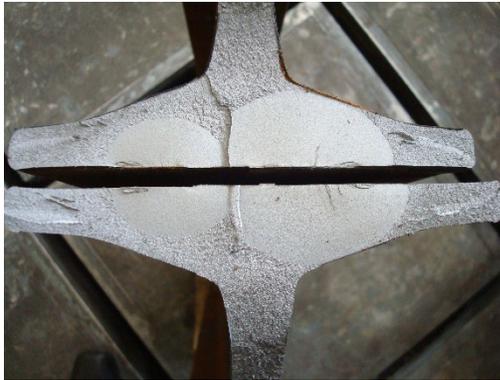
Fig. 5. Fatigue crack of flash butt welded joint of R260 grade rails (source: author)

Fatigue testing of flash butt welded rail joints is a perfect way of verifying the correctness of the rail flash butt welding process. Any defects occurring during that process affect the strength and ductility of the joints, causing them to crack. These cracks were observed at different times during the dynamic fatigue tests. In the presence of larger dull patches, joint cracking occurs in the range up to 1.0 million fatigue cycles, while with small patches above 3.0 million cycles. These discontinuities are the source of fatigue cracking of rail joints. Figures 5 and 6 show the fractures of flash butt welded joints that underwent separation cracks during fatigue tests at cycles up to 3.0 million.

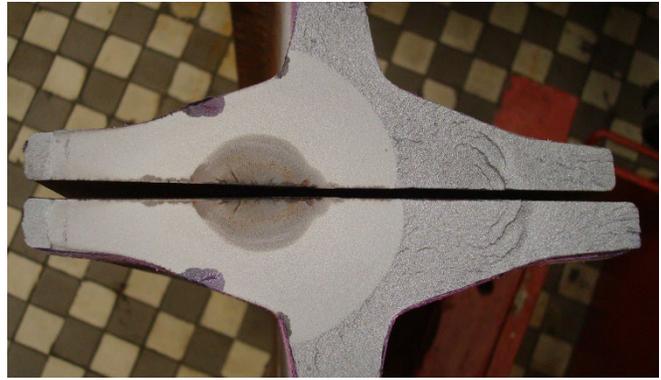
Fig. 6. Fatigue crack of a flash butt welded joint of R350HT grade rail (source: author)

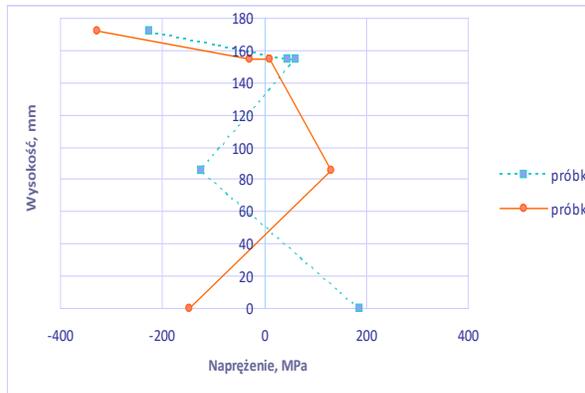
Fig. 7. Stress distribution in a rail and flash butt welded joint of R260 grade (source: author)

Plot description: A1, B1 – rail; A2, B2 – rail joint. Plots labels: Wysokość – height; Próbką – specimen; Stopka szyny – rail foot; Naprężenie – stress; Główka – head rail.

Strain gauge testing of R260 and R350HT grade rails and rail joints before installation on the track is shown in Fig. 7 and Fig. 8. The graphs show the presence of tensile stresses in rails and compressive stresses in rail joints. The highest stresses in the rails were recorded in the railhead above ± 200 MPa and the rail foot at +195 MPa and +230 MPa, respectively, while in the joints at -175 MPa and -90 MPa, respectively.

As a result of the tests, it was found that the stresses in the feet and heads were tensile, while in the web of the joints, they were compressive. This is consistent with the stress direction in the new rails coinciding with the stresses shown in Fig. 7 and Fig. 8.

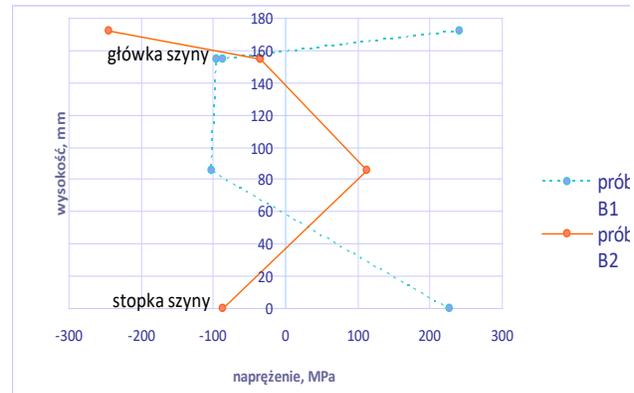
Fig. 8. Stress distribution in a rail and a flash butt welded joint of R350HT (source: author)

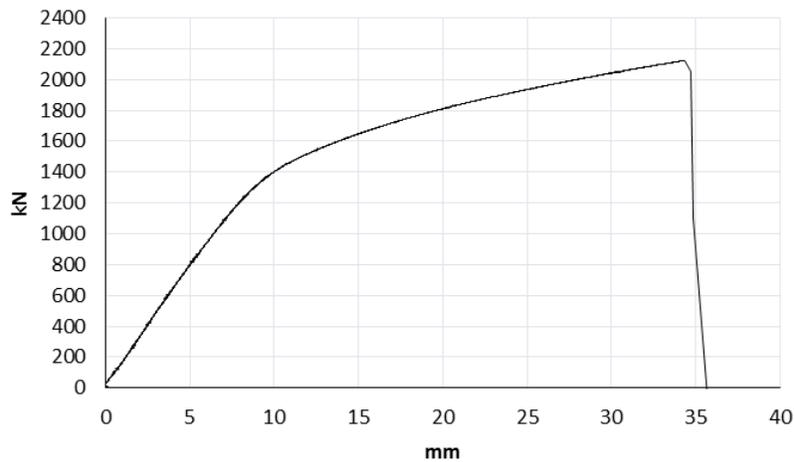
Fig. 9. Bending diagram of rail joint of specimen No. 13 (source: author).

The bending strength tests of flash butt welded rail joints of the above grades are presented in Table 1. Three-point support with swing support was used during the bending test. The highest mean forces needed to fracture the joint were recorded for the R400HT grade, i.e. 2081.0 kN, while the displacement for the R350HT grade joints was 48.8 mm. The required bending force for these grades should be at least 1600kN, and the displacement should be at least 15.0 mm and 20.0 mm, respectively. A diagram of the bending test for specimen No. 13 is shown in Fig. 9.

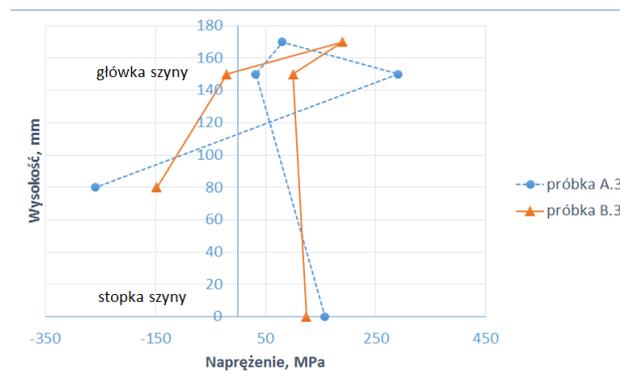
Fig. 10. Internal stresses in R260 and R350HT joints after fatigue tests, A3 - R260 joint, B3 - R350HT joint (source: author).

Plots labels: Wysokość – height; Próbką – specimen; Stopka szyny – rail foot; Napężenie – stress; Główka – head rail.

The stresses in the joints of R260 and R350HT grade rails after fatigue tests simulating the operation of the rails during train running were examined using the strain gauge method. The magnitudes of the internal stresses were continuously recorded while cutting the joints with glued strain gauges. Fig. 10 shows the residual stresses in the joints' foot, head, and web. They do not exceed the 250MPa value required by the standard.

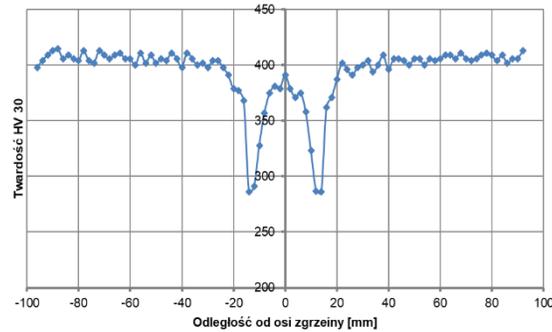
Fig. 11. HV30 hardness on the longitudinal section of the flash butt welded joint (source: author).

Plots labels: Twardość – hardness; Odległość od osi zgrzeiny – distance from weld axis.

The HV30 hardness tests of the rail joints were carried out on the longitudinal section at a distance of 5.0 mm from the rail rolling surface with a measurement every 2.0 mm. The results compliant with the standard requirements [1] were obtained on all samples. The course of HV30 hardness in specimen No. 13 is shown in Fig. 11.

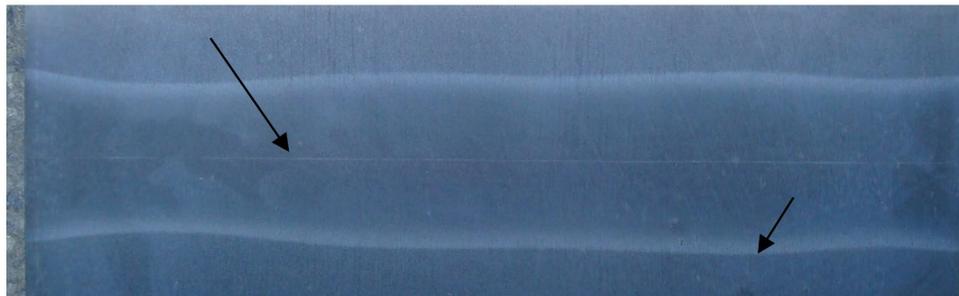
Fig. 12. Macrostructure of the R260 grade rail joint after flash butt welding (source: author).

Examination of the macrostructure for the above grades revealed no internal defects such as nonmetallic inclusions, internal cracks, or unwelded places. The macrostructure of the joint is shown in Fig. 12, with the flash butt weld line and the heat-affected zone visible.

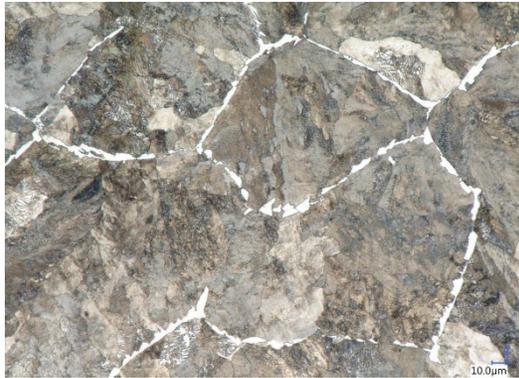
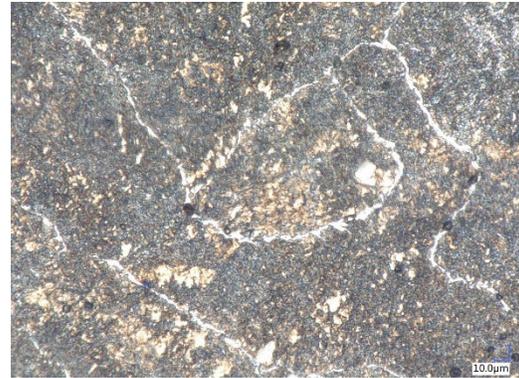
Fig. 13. *Microstructure of the flash butt welded joint head of R260 grade rail after fatigue tests (source: author)* **Fig. 14.** *Microstructure of the flash butt welded joint head of R350HT grade rail after fatigue tests (source: author)*

The examination of the microstructure of the joints included the study of the flash butt weld line and the heat-affected zone. In the joints of R260 and R350HT steels, with the carbon content at the lower limit provided by the standard, a differentiated pearlitic structure was found in the flash butt weld line, with separations of ferrite on the borders of former austenite grains (Fig. 13 and 14). In contrast, separations of sorbitol and fine perlite characterized the heat-affected zone.
