Study of damage and repair of flax/Elium biocomposites under dynamic loading

Keywords: Biocomposites, Flax Fibres, Thermoplastic Matrix, Repair, Dynamic Behavior, Damage

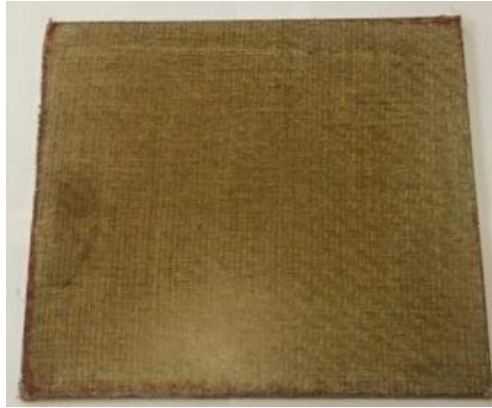
Plates, of dimensions $1000 \times 750 \text{ mm}^2$ with a thickness between 4.5 and 4.8 mm, were manufactured by CMP Company using Vacuum Resin Infusion (VRI) (figure 1). This latter is usable although it used thermoplastic matrix because of the very low resin viscosity.

Fig. 1. biocomposite plate

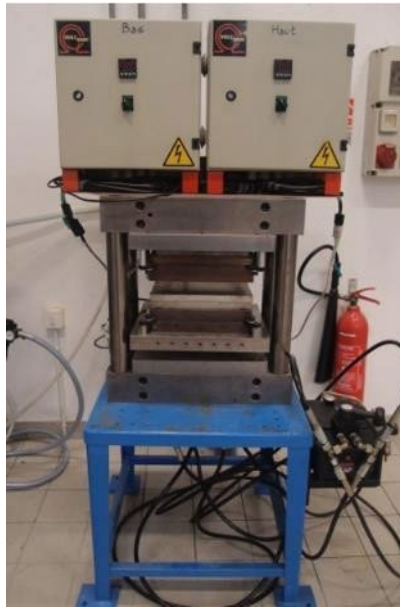
An in-house thermocompression device (Figure 2) was designed in our laboratory to manufactured thermoplastic-based composites. But, in our case, it has been used to repair the impacted plates. For that we put on the impacted sample a coupon of a comingled fabric with flax and polypropylene fibres. The size of this latter was approximately the damaged area. Using a temperature of $200 \text{ }^\circ\text{C}$ and a very low pressure to avoid changing the dimensions and more especially the thickness the plates were repaired.

Samples were put in between the two aluminium trays and we just added an weight of 5 kg on the upper plate. 5 minutes was enough to make flat again the impacted samples.

Fig. 2. Conventional hot press.
