Mechanics and failure analysis of stitched sandwich structures damaged by the impact of various energies

Keywords: Mechanical, Failure Analysis, First Impact, Stitched Sandwich, Damage, Shock Accumulation, Shock without Rebound

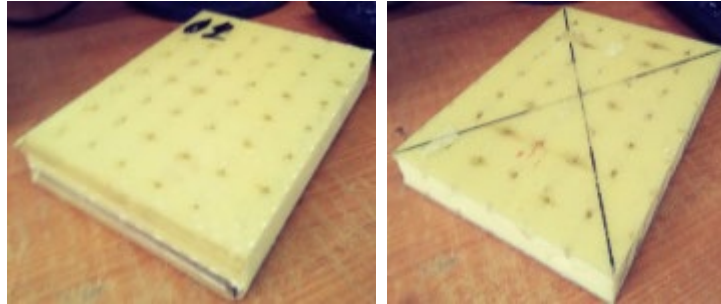
The specimens shown in Figure 1 of this study consist of stitched sandwich panels to woven composite skins. These panels measure 200 mm by 150 mm and are 23 mm thick. The skins themselves are composed of two identical layers of woven glass fibers 1.5 mm thick each, with a density of 400 kg/ m³. They envelop a polyurethane foam core 20 mm thick and with a density of 35 kg/ m³. The integrity of the "skins-foam core" suit is reinforced by a seam composed of 2400TEX glass rovings.

Fig. 1: Specimen

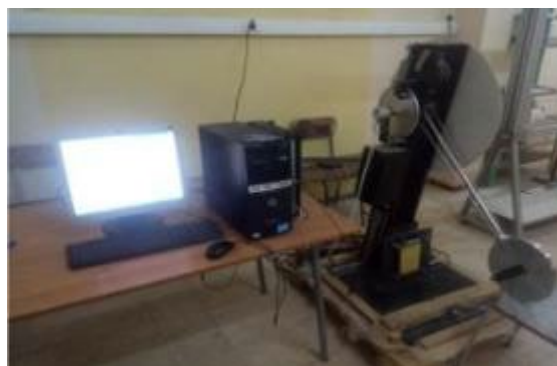
The operating mode shown in Figure 2 consists of a test bench ensuring the principle of soft impact by falling weight (steel disc + impact head) totaling a mass of 11 kg. The collider thus formed is equipped with a hemispherical impact head with a diameter = 25 mm which allows the impact to be focused. The support system is made to ensure a perpendicular application of the load on the embedded plate in order to avoid any parasitic movement of the specimen Figure 3.

Fig.2: Experimental impact setup

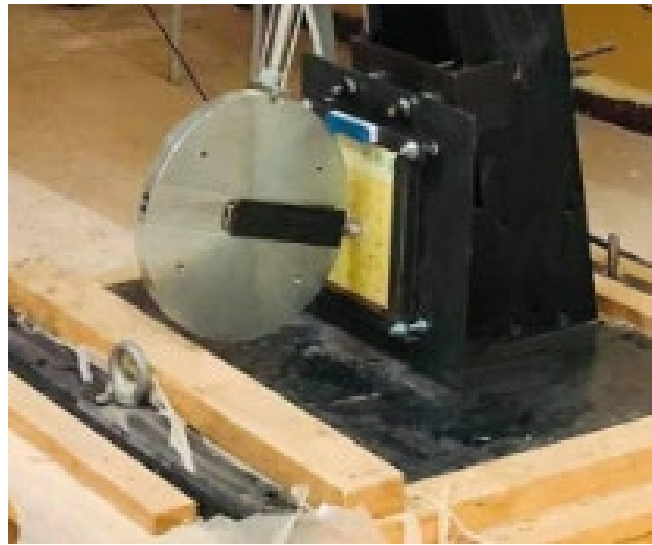
Fig.3: Collision between the collider and the embedded sample

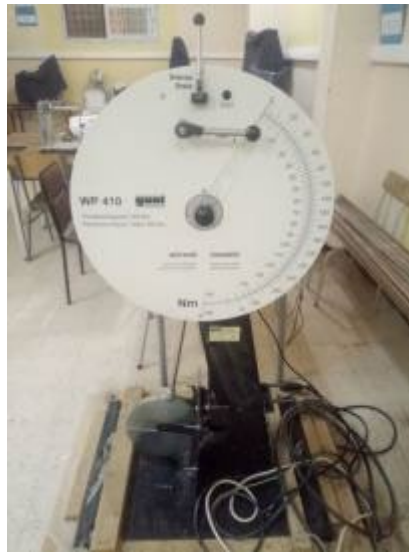
- The energy is given using a graduated disk which makes it possible to lift the mass to the height corresponding to the desired energy Figure 4.

Fig.4: Graduated disk

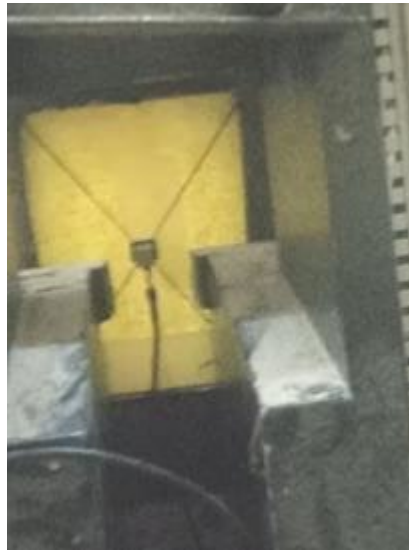
- The bench is equipped with a braking system which makes it possible to avoid the rebound of the collider.
- The acquisition mode is ensured by Pulse software which is linked to the non-impacted face of the specimen by a sensor Figure 5 bellow.
- For the survey of the deformations of the impacted face (diameter of impact and depth of indentation) they are carried out by an electronic caliper.
- The tests, as can be seen in the previous figures, were carried out according to the above methodology.

Fig.5: A sensor linked to the non-impacted face of the specimen

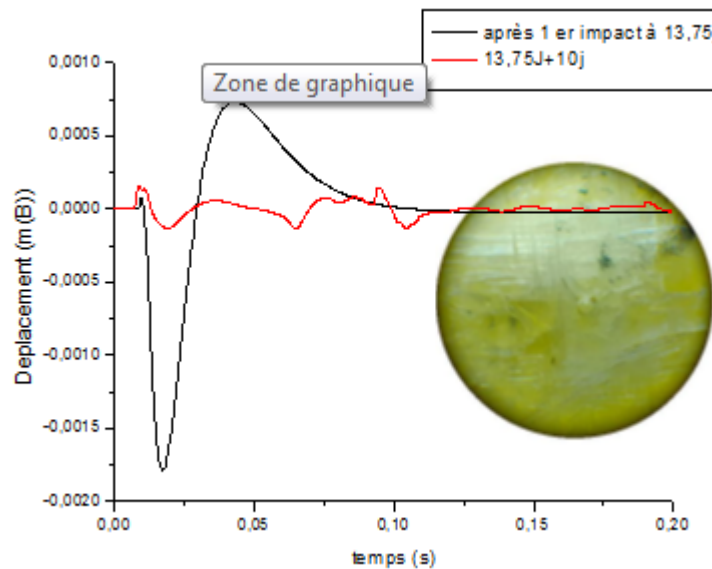
Fig.6: The vibrational response (displacement history) of the non-impacted skin resulting after two impacts: 13,75 J and 10 J

The photo in figure 6, show the vibrational response (displacement history) of the non-impacted skin resulting from the first impact at 13.75 J and the second impact with an energy of 10 J where we notes that the deformation effect of the second impact is negligible. In fact, this is well expressed on the graph of the vibrational responses of the non-impacted skin, where lower

amplitudes are observed for the second impact. On the other hand, the impacted skin did not show an increase in the diameter or depth of the impact table 1.

After evaluating the behavior of the stitched sandwich under the effect of the first impact, a second impact was applied with a constant energy of 10 J for all the specimens already impacted (13.75-24,75- 35,75 and 55 J). In this experiment the effect of the accumulation of shocks was observed. The following figures 6, 7, 8 and 9 explain the results where the graphs showing the vibration behavior of the non-impacted skin are superimposed, while the photo shows the cumulative effects of the two shocks on the impacted face.

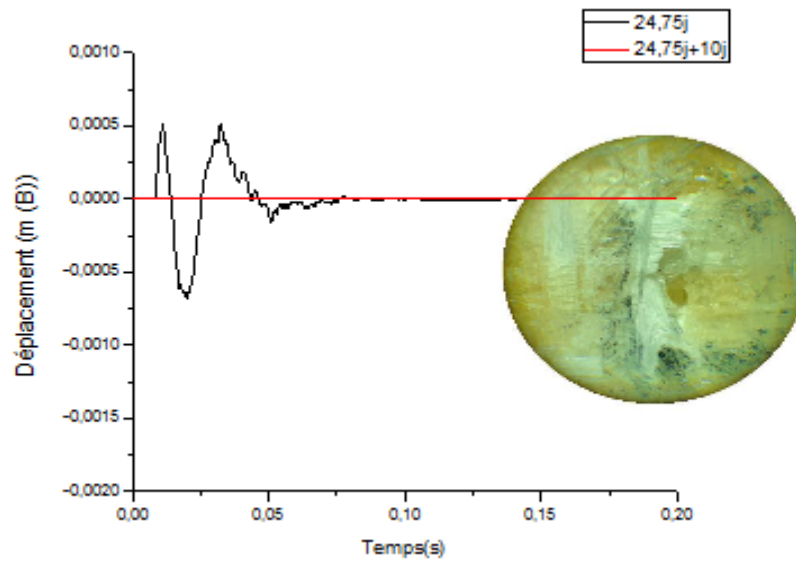
Fig.7: The vibrational response (displacement history) of the non-impacted skin resulting after two impacts: 24,75 J and 10 J

For the specimen in figure 7, it is noted that the vibrational response of the non-impacted skin to the second impact is weaker compared to its response to the first. The phenomenon is certainly due to the absorption of the shock by the fiber debris and resignation resulting from the first damage. On the other hand, the impacted skin shows a 28% increase in the impact diameter (table 2). For the depth, the exaggerated increase (5 times) is indeed justified by the low resistance of the foam.

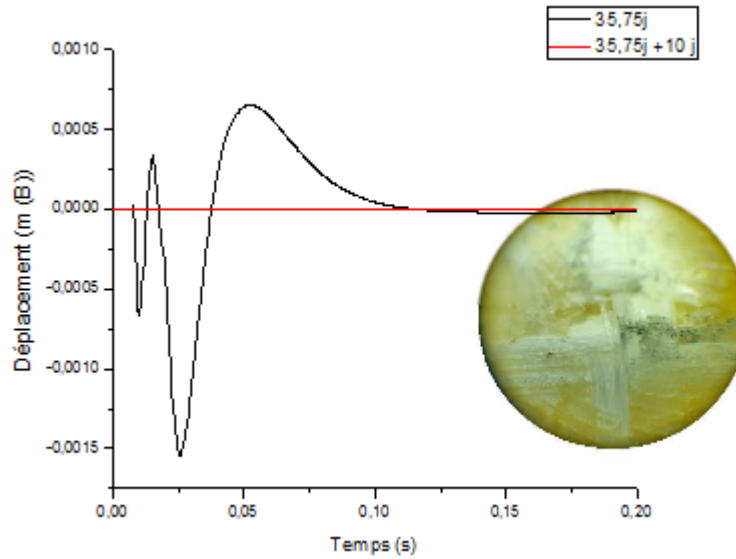
Fig. 8: The vibrational response (displacement history) of the non-impacted skin resulting after two impacts: 35,75 J and 10 J

For the test specimen in figure 8, we find ourselves in the particular case where the plate undergoes two impacts on a sewing knot. The vibrational response of the non-impacted skin to the second impact is weaker compared to its response to the first. The phenomenon is due to the absorption of shock by the presence of the seam. On the other hand, the impacted skin shows an increase of 4% in the diameter of the impact (table 3) and 35% in the depth of indentation.

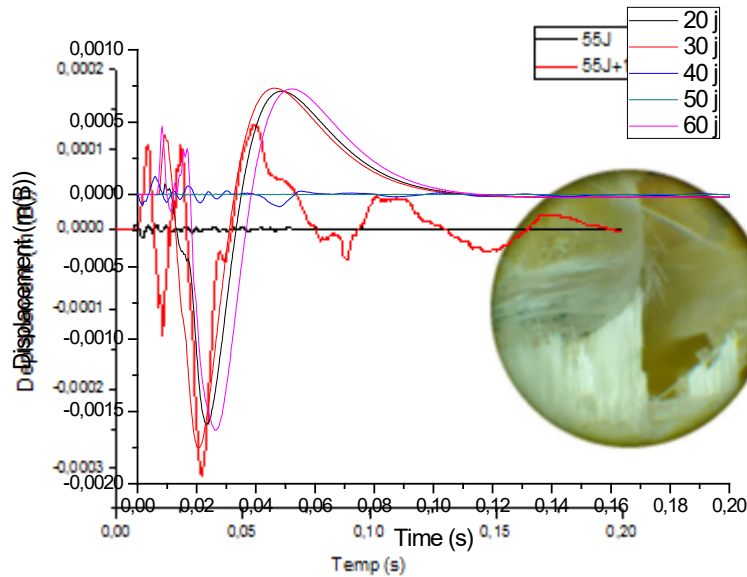
Fig.9: The vibrational response (displacement history) of the non-impacted skin resulting after two impacts: 55 J and 10 J

Figure 9 shows the vibration response of the non-impacted skin resulting from the first and second impact at 55 and 55+10 d. It is noted that unlike the previous plates, the response of the non-impacted face in this case is greater. In fact, at the first impact, the impacted face has been completely perforated, which causes the non-impacted skin to undergo the second shock directly. The impacted skin on its side showed a 9% increase in impact diameter (Table 4) and 15% in indentation depth. It can be seen that the compression of the debris prevents the sinking of the collider head.
